82559 Fast Ethernet Multifunction PCI/CardBus Controller

Stepping Information

October 2004

Revision 2.2

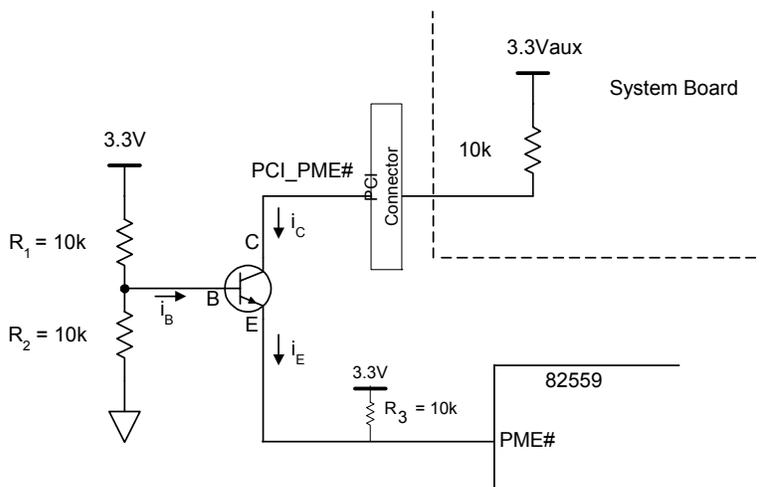
Problem: During power cycle events, the electrostatic discharge (ESD) elements internal to the 82559 may falsely clamp the Power Management Event (PME) output signal to approximately 1.5 volts for 100 ms to 150 ms during initial power up. This can cause wake-up events to be recognized by the system if power management events are enabled in the system chipset. This may result in a problem for mobile environments since the false clamping can cause a suspended system to wake up when the power to the LAN device is transitioned.

Implication: The implications of this anomaly depend on the target system configuration. In desktop and server systems, the impact is limited to a false wake-up event occurring when a new card is installed. In mobile systems where the LAN power is transitioned more frequently, the PME signal should be disabled during transitions.

Workaround: False PME indications can be avoided by disabling the recognition of a PME before removing or restoring power to the 82559. If a hardware solution is required, the following isolation circuit has been proven to be effective. The circuit requires the PCI PME signal (PCI_PME#) to be isolated from the 82559 PME signal (PME#). The system does not see the 1.5 voltage level drop caused by the 82559's power transition.

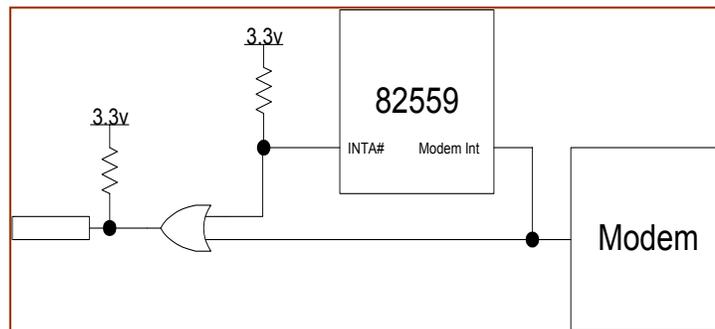
Problem: The propagation of modem interrupts in the 82559C is linked to PCI clock activity. The 82559C local interface enables ISA based modems to operate in a PCI environment. In Advanced Configuration and Power Interface (ACPI) systems, the operating system may place the 82559 in the D3 power state and shut down the PCI clock while the modem is active. This prevents the 82559 from clocking modem interrupts to the system.

Implication: If the Clockrun protocol is used, the PCI clock can be shut down during modem sessions. In this case, the modem interrupt is not propagated through the 82559 to the Interrupt A pin.

Workaround: Three possible workarounds for this anomaly are listed below:

1. Disable the Clockrun signal during modem use.
2. Drive the Clockrun signal directly from the modem using external circuitry.
3. Drive the Interrupt A pin directly from the modem.

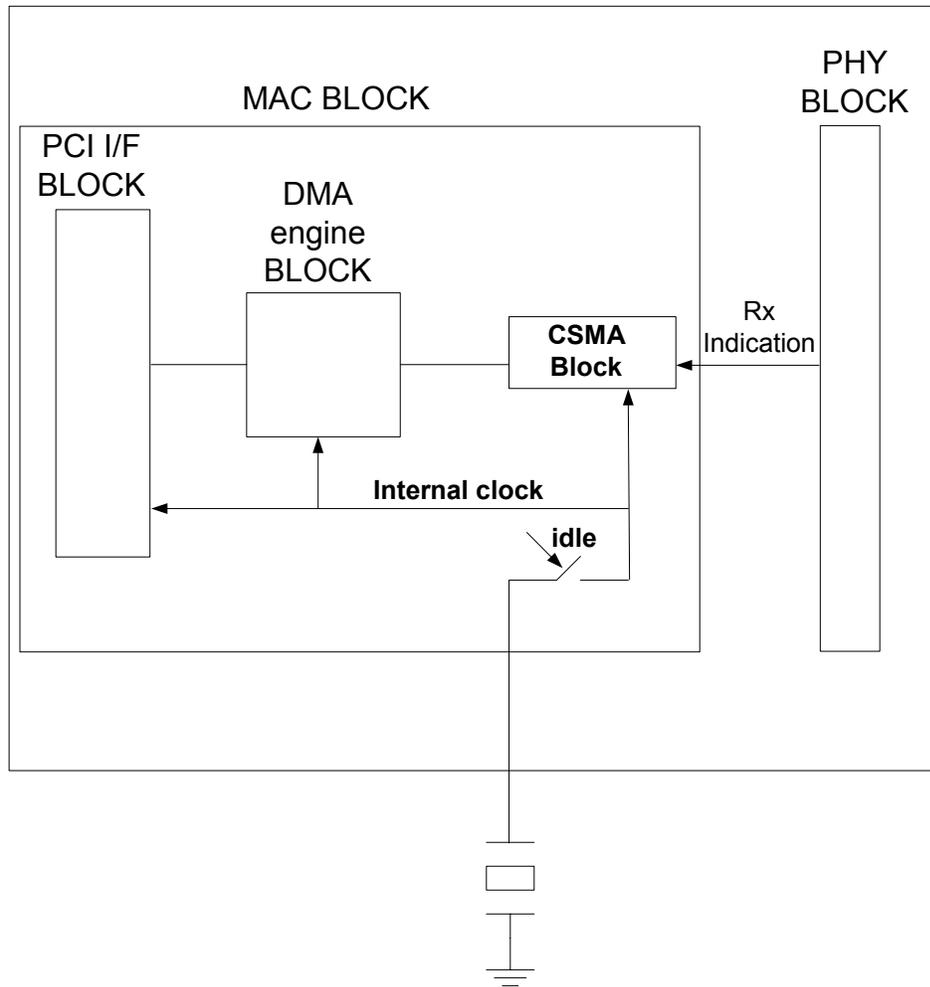
In Dynamic Standby mode, a possible synchronization condition may occur preventing the device from waking up when it receives an incoming frame. If this happens, the frame is not properly handled and is lost.

When the 82559 (B-step) is in the Dynamic Standby mode, clock signals to the MAC are stopped. Any received packet that passes address filtering causes the MAC block to wake up. The MAC block wakes up in a specific timing window by synchronizing between a recovered clock and

internal generated clock. A synchronization problem occurs between the recovered clock and internal generated clock. This window in which the problem can occur is identified as approximately 20 clocks at the beginning of the reception of a packet.

Implication: The probability of this synchronization problem occurring is low with slower material but increases with faster material. The reason for this is assumed to be due to fabrication process variation.
