RK8-E Handouts

RK05 Reference B938

digital	FIELD SERVICE TECHNICAL MANUAL				Option or Designator
	12 Bit <input checked="" type="checkbox"/>	16 Bit <input checked="" type="checkbox"/>	18 Bit <input type="checkbox"/>	36 Bit <input type="checkbox"/>	RKØ5

Title +5 VOLT REGULATOR 5409503				Tech Tip Number RKØ5-TT-1	
All	Processor Applicability			Author J. WALSH/A. MUIR Rev Ø	Cross Reference
	8	11		Approval HAROLD LONG Date 9/12/72

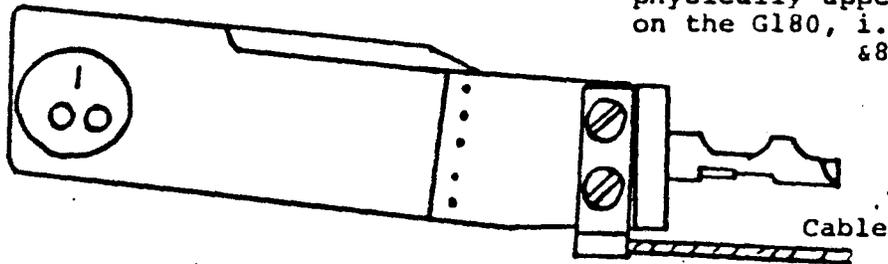
LOWER HEAD
30-10863-01

(Cable will plug into the physically upper set of pins on the G180, i.e. pins 5,6,7 & 8)

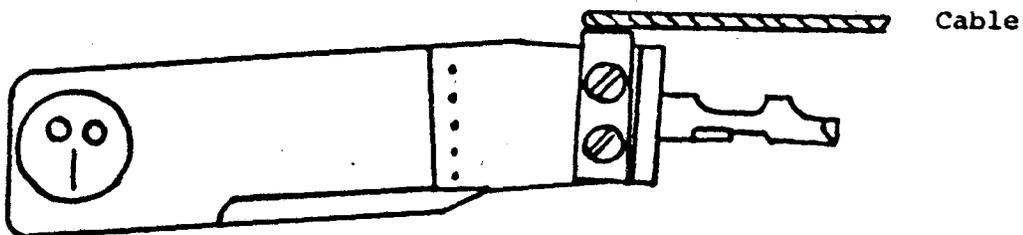
UPPER HEAD
30-10863-02

(Cable plugs to pins 1,2,3 & 4 on the G180)

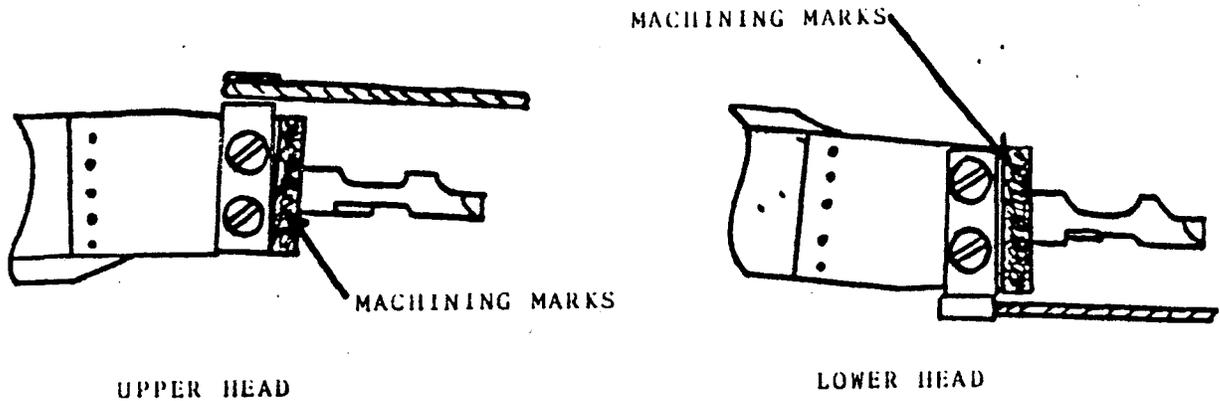
An ECO to the carriage assembly and one to the tailpiece of the R/W heads involved the machining of the flat surface where the head rests on the tang of the carriage. The new REV head will fit in the old REV carriage assemblies. Caution should be exercised however to insure that the pad of the head is on a plane which is parallel to that of the disk surface.

Heads on old REV tailpieces will not fit into new REV carriage assemblies.

New REV tailpieces can be identified by the machining marks on the shoulder. See Figure 1.

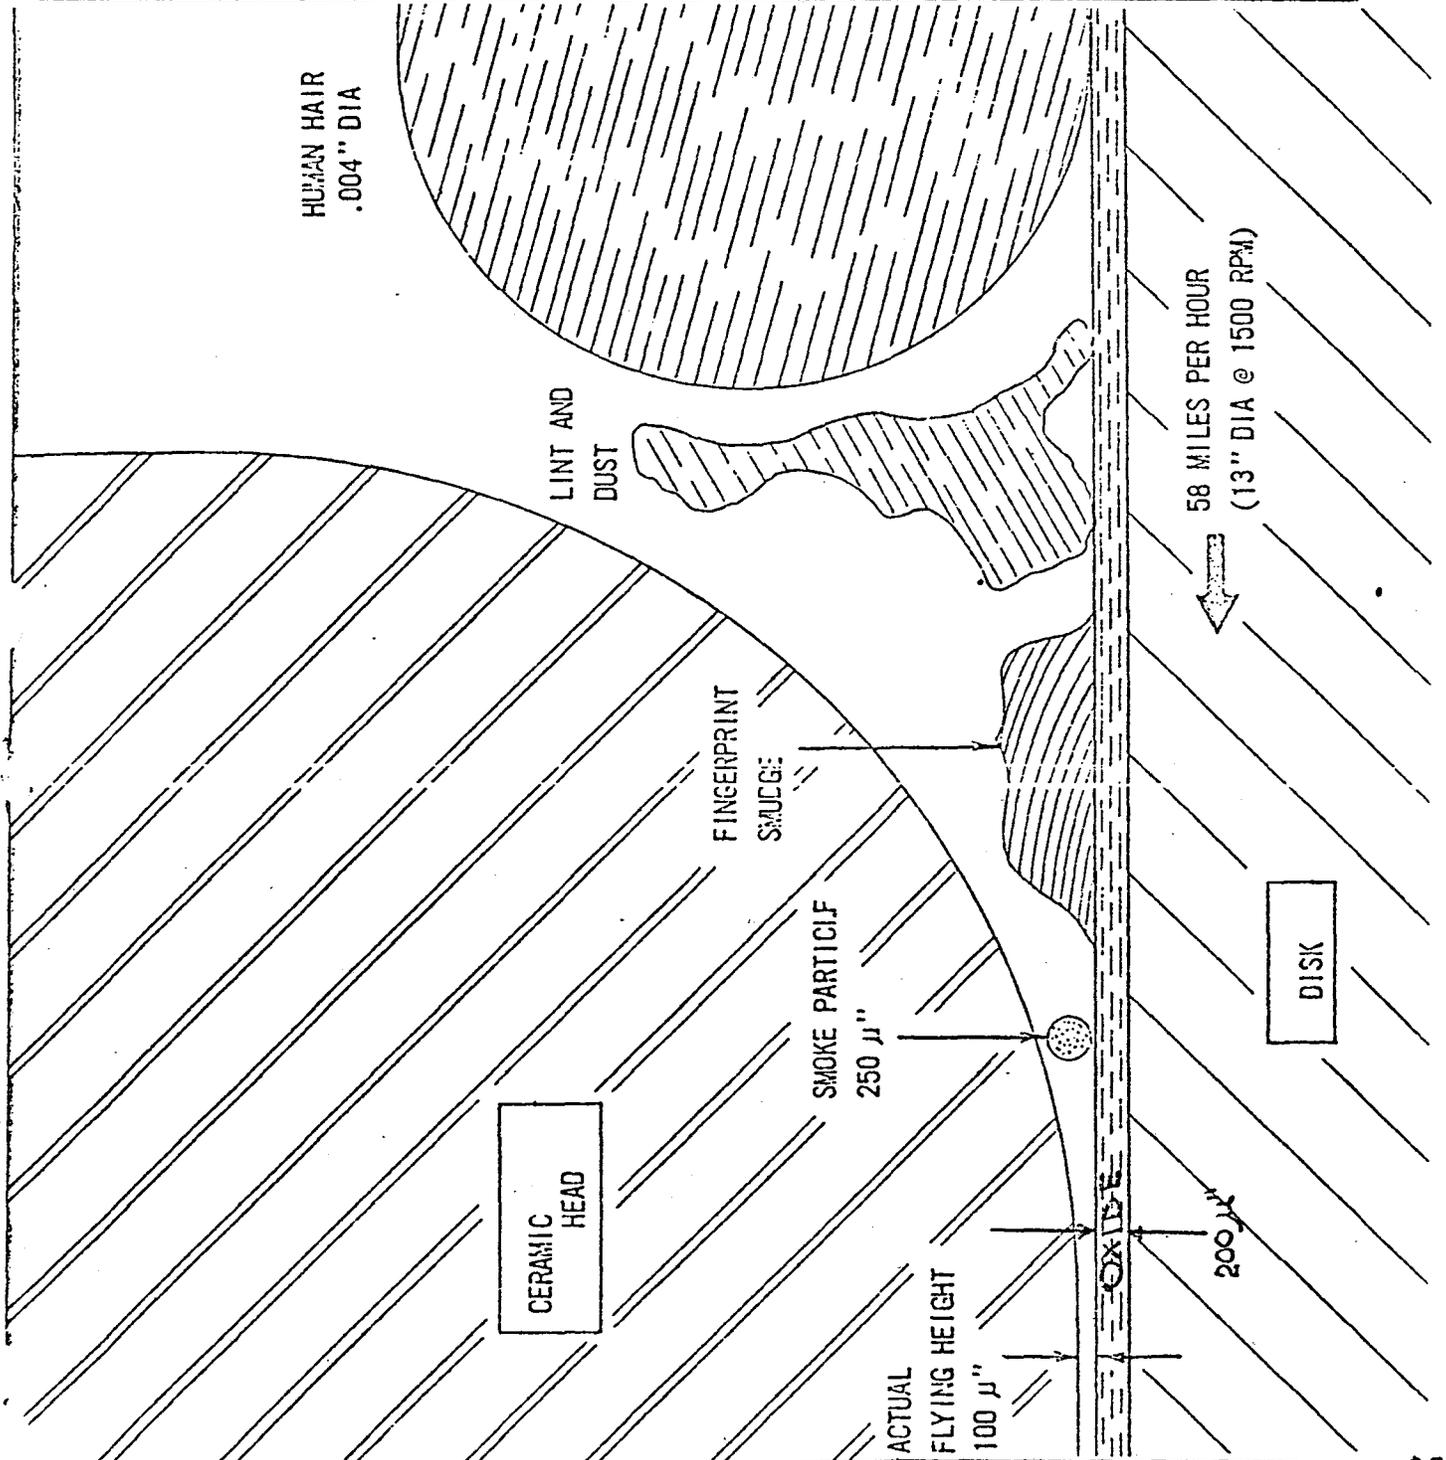
See attached picture. Yes, the head in an RK05 (or similar) disk drive actually "flies" closer than a finger print smudge or large smoke particle -- let alone a spec of dust, flake of dandruff or a hair. This may give you some idea why, when you can write your name in the dust on the outside of the disk cartridge, you may get disk oxide building up on the white ceramic head. Oxide build-up on the heads causes improper head flight and ERRORS if your're lucky-- CATASTROPHIC DESTRUCTION OF HEADS AND DISK if you're not. Keep the disk cartridge door shut and the disk in a clean bag or clean environment when not in the drive. And that's only dirt. There are other ways you can wreck a cartridge and/or drive; such as:

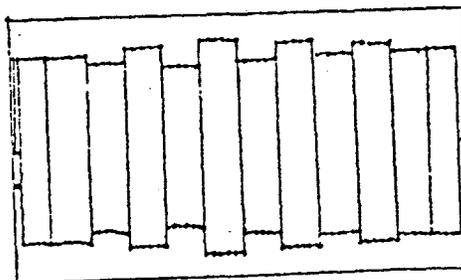
Figure 2
Considerable runout. NOTE: If this condition exists ensure that mating of spindle and disk are clean. Improper mating can cause such runout.

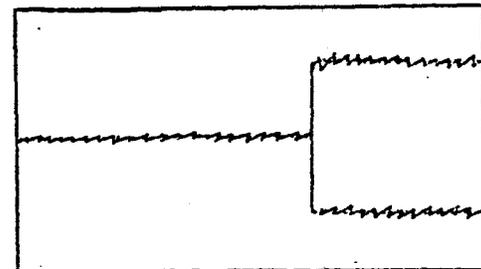
a. Error = -100%

Large misalignment. Head close to CYL 104. (Further misalignment only reduces signal on right of screen).

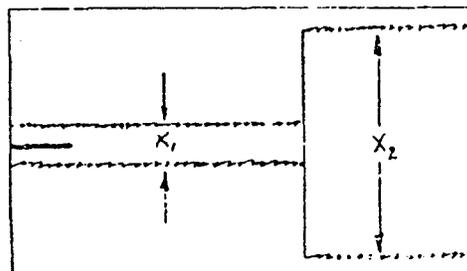
b. Error = -72%

Head considerably misaligned. Smaller left amplitude indicates head position less than CYL 105.

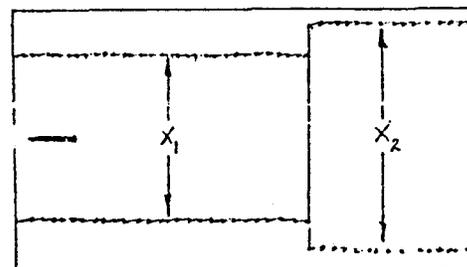
c. Error = -15%

Head slightly misaligned. Smaller left amplitude indicates head position less than CYL 105.

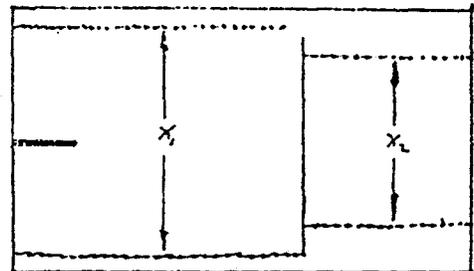
e. Error = +15%

Head slightly misaligned. Larger left amplitude indicates head position more than CYL 105.

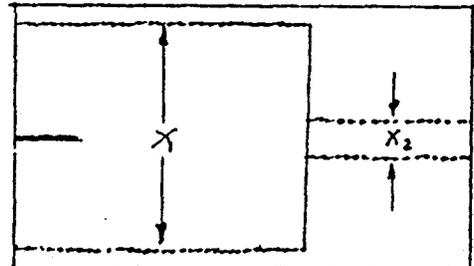
f. Error = +72%

Head considerably misaligned. Larger left amplitude indicates head position more than CYL 105.

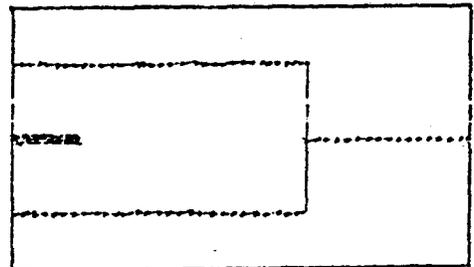
g. Error = +100%

Large misalignment. Head close to CYL 106. (Further misalignment only reduces amplitude of signal on left side of screen).
