CUSTOMER ENGINEERING

NEWS LETTER

January 14, 1957

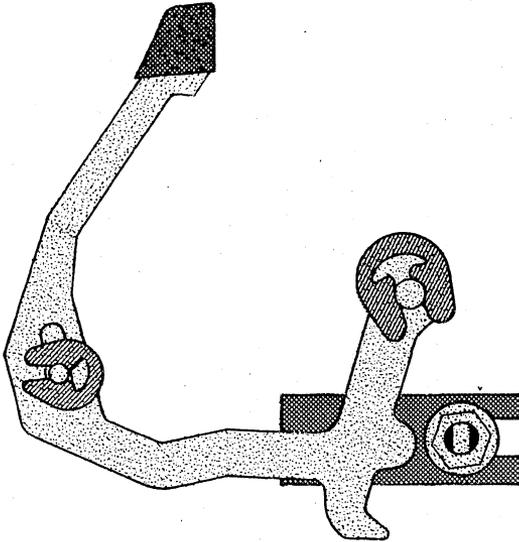
LOOSE MODEL A CARRIAGE RELEASE BAR

A method which prevents the carriage release bar from coming out of its pivot holes on Model A ET's has been suggested by William Williams, Customer Engineer of the Detroit Branch Office, and is as follows:

1. Break a standard segment guide spring 1 1/4" from the slotted end.
2. Loosen the margin rack nut.
3. Place slotted end of the segment guide spring under the release lever and parallel to the bottom of the end plate under the large margin rack washer.
4. Tighten margin rack nut.

The segment guide spring reduces the release shaft end play and will not bind off the carriage release lever.

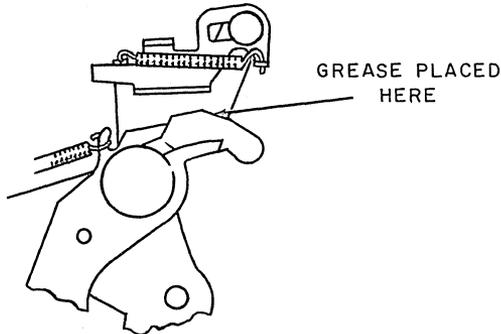
IMPROVEMENT OF TOUCH

A procedure for improving the touch on Standard Model BET's is suggested as follows:

1. Place the machine on its back with the switch off.
2. Push each cam in succession into the power roll. This may be done by pushing on the nylon tail of the cam. Turn the power roll by hand until the cam reaches the knockoff point.

3. Using a spring hook or similar tool, apply a very small amount of #17 grease to the area where the trip lever contacts the cam. Care should be exercised not to over-lubricate, as this could result in possible migration of grease to the power roll. When lubricating a complete set of cams in this manner, it is recommended that the cam knockoff bar be removed (Standard ET) to facilitate lubrication.

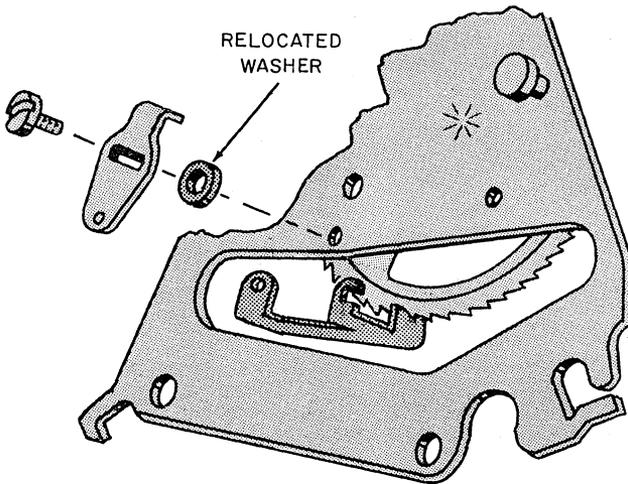
HINT: RIBBON FEED

Occasionally, as a result of critically aligned check pawls on the fabric ribbon feed mechanism, the check pawl misses the spool teeth. A method for correcting this is to remove the washer, part #1090472, from the outside of the check pawl and to reinstall it between the check pawl and the ribbon mechanism feed plate. This relocates the check pawl tip closer to the inside of the ribbon feed plate by the thickness of the washer.

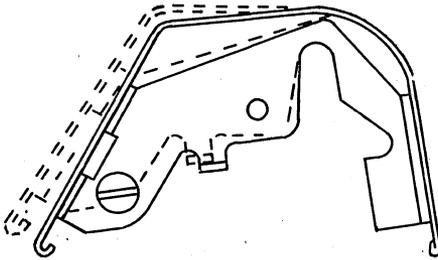
SPREADING THE PAPER TABLE

Occasionally the rear edges of the paper deflector on longer carriages offer interference to paper insertion as a result of insufficient overlap of the paper table to the rear edge of the paper deflector. This interference may be eliminated by loosening the screws at either end of the paper table and rotating the paper table toward the front of the ET as far as possible. Then, by forming the paper table outward (essentially, spreading it) along its entire length, interference of the deflector edge to the inserted paper may be eliminated.

NOTE: Caution should be used while forming to prevent possible contact of the rear edge of the paper table with the margin set finger.

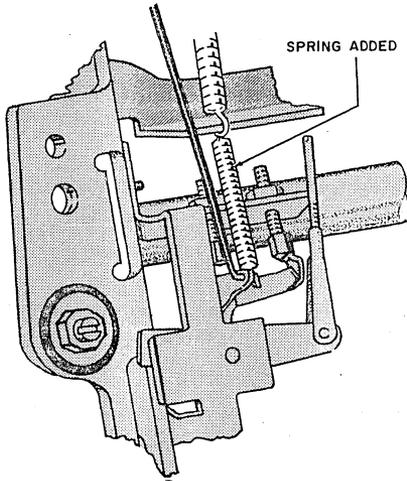
SPACE BAR CAM SLIPPAGE

Prevention of space bar cam slippage on Executive ET's as a result of insufficient pressure of the cam against the power roll may be obtained by a method as suggested by W. A. "Red" Ekelund of the New York Uptown Branch Office. "Red" suggests that by hooking one end of a shortened cam lever spring, Part #1071318 around the tip of the escapement connecting link with the other end hooked in the hole in the selector bar guide helps in forcing the cam tighter against the power roll resulting in a more reliable space bar operation.

This may be helpful in correcting certain space bar operations where insufficient cam pressure is a problem and particularly for those cases where the ET is in a cold location. This procedure should be used only when all other adjustments and parts are found correct.

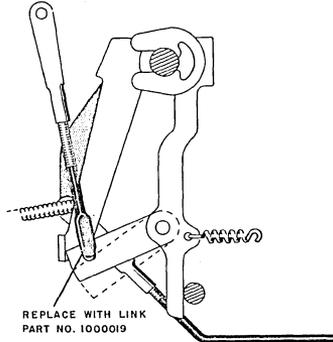
REVERSING EXECUTIVE SPACE BARS

An operator may prefer that the left space bar escape 2 units and the right space bar escape 3 units.

Reversing of Executive space bar escapement in this manner may result in a bounce of the left hand space bar when the right hand space bar is operated. This is caused by the bottom of the actuating lever contacting the top of the space bar interposer (in the lower position to which it has been adjusted.)

Reversing the Executive space bar escapement may be easily accomplished by the following procedure:

Replace the connecting link, part # 1014536, between the space bar key lever and the escapement cam, with longer link, part # 1000019. The longer link should be adjusted to allow the interposer to clear the bottom of the formed lug on the space bar actuating lever by a minimum of $1/32$ " when the left hand space bar is operated (at the point of cam trip.) When the right hand space bar is depressed the interposer will contact the actuating lever causing three units of escapement. When the left hand bar is depressed the interposer will move below the actuating lever, causing only two units of escapement.

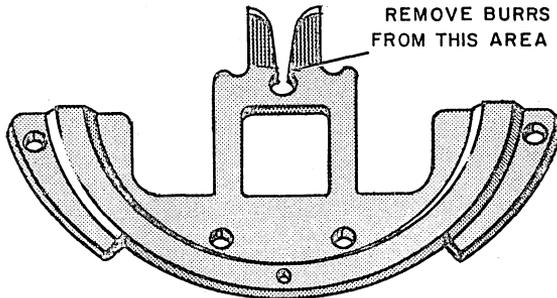
POLISHING TYPE GUIDE

Type bar center guides are now being vapor blasted to eliminate burrs around the slotted portion of the center guide, and to prevent type bars sticking in the center guide. This condition may be alleviated on ET's with this trouble by using crocus cloth in the area of the guide above the small round hole, as shown in the illustration.

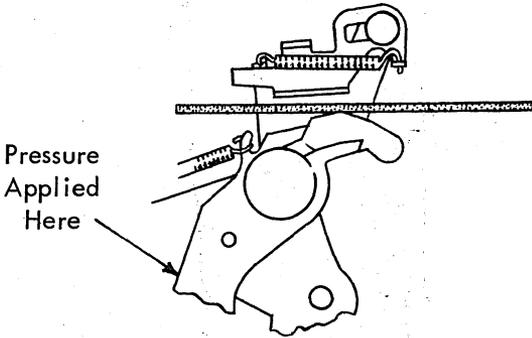
HEAVY TOUCH??

In News Letter #43, a procedure was presented for improving touch on Model B Standard ET's. Another method for improving touch which has been used successfully in several Branch Offices is that of flexstoning the edge of the nylon cam as shown in the accompanying illustration. This is accomplished as follows:

Remove the cam levers from the ET.

Rounding of this corner, however time consuming, may result in reducing critical touch problems. It is suggested that this method of improving touch be used only when all other known methods have failed.
