CUSTOMER ENGINEERING

NEWS LETTER

January 30, 1958

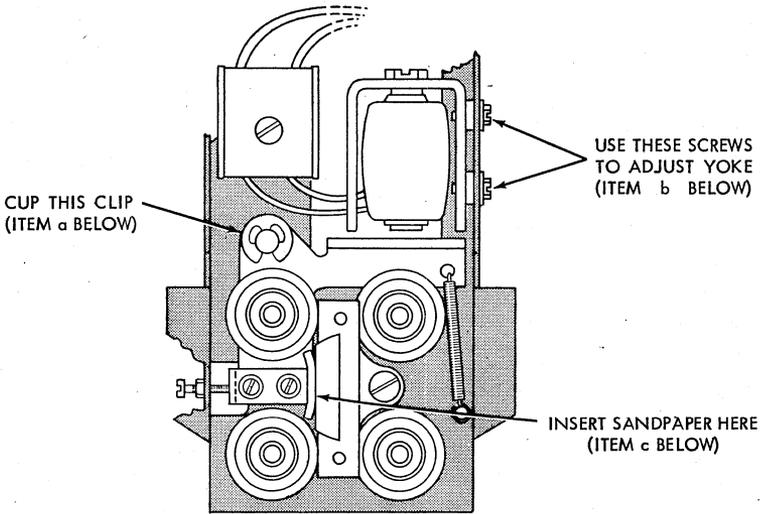
The following adjustments have been found helpful for improving ribbon feed on the Model B Hektowriter.

1. Increase the carriage tension to approximately 3.5 pounds.

2. Eliminate play in the auxiliary carriage magnet armature as follows:
 - a. "Cup" the magnet armature C clip slightly so that a slight pressure is exerted downward on the armature.
 - b. Adjust the magnet yoke by means of its 2 supporting screws so that the armature contacts the yoke squarely. A slight angle at this point will result in the armature being cocked when attracted to the magnet and ribbon slippage may result.
 - c. Insure that the brake shoe contacts the rubber brake squarely. The shoe can be formed slightly to effect this condition. If the rubber pad does not appear to have a flat surface, insert a fine grade of sandpaper between the brake shoe and pad and sand the pad until a flat surface is attained.

3. Adjust the air gap between the magnet armature and its stop to approximately .012" to .015".
4. Insure that there is some clearance between the shoulder of the friction disk assembly (area just above the large C clip) and the bottom shoulder of the reverse lock assembly (part in top flange assembly with square hole through center.)

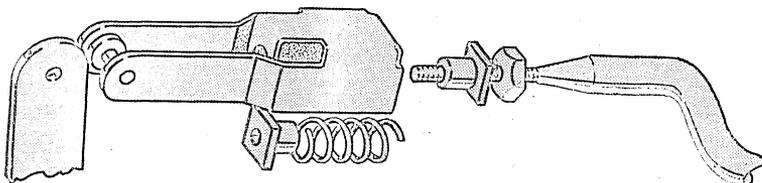
REDUCING MARGIN SET LEVER BENDING

Bending of the margin set lever, another problem frequently encountered in school installations by operators unfamiliar with setting margins, can be alleviated by the following procedure:

The spring loaded clevis (#1105838), formerly used with the universal bar trip link, (Parts Catalog, Cam and Typebar Section) is assembled as shown in the accompanying illustration. This is accomplished by moving the plunger (#1104419) to the other end of the clevis (#1104421) which in effect changes this clevis from a pushing type of clevis to a pulling type. It will be necessary to replace the clevis spring with a heavier compression spring (#1093650) with 3 loops removed.

When installing the spring loaded clevis on the connecting link, place an additional plunger at the lower end of the clevis as shown in the illustration. This is placed in an opposite direction to the plunger already installed in the clevis. This will allow better movement of the link in the lower clevis hole. It is also suggested that a lock nut (#1091057), be placed below the lower plunger to prevent loosening.
