TO: ALL CUSTOMER ENGINEERS

The attached News Letter is intended to replace all News Letters issued since the announcement of the Model C in January, 1959. All information considered pertinent at this time has been grouped by mechanism for your convenience. This should be particularly helpful to new Customer Engineers who have not received back issues of News Letters.

TABLE OF CONTENTS

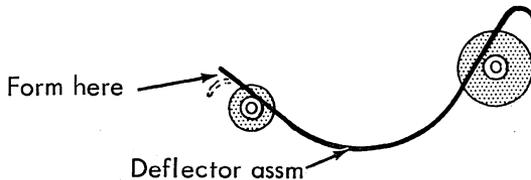
FORM DEFLECTOR FOR FORMS TEARING ON ROLLBACK

Tearing of continuous forms during rollback may be traced to the form catching on the front lips of the deflector. The front lips may be formed outward as illustrated to remedy this condition. Caution: After forming, be sure the front scale clears all obstructions without binding.

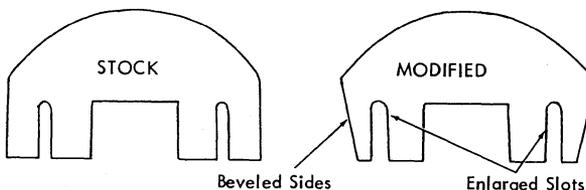
QUICK INSTALLATION - UNDERPRINTING SHIELDS

Modify underprinting shields, P/N 1260385, as illustrated for easy insertion and adjustment.

The beveled sides make insertion easier and the enlarged slot makes vertical adjustment easier after the shield is in place.

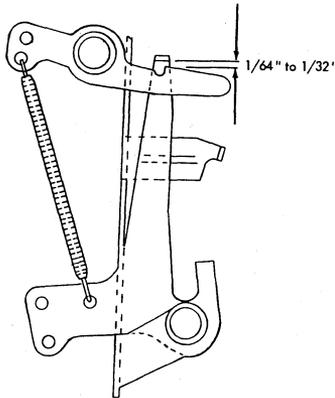
To check the Model C clutch for unlatching during the last $1/64$ " to $1/32$ " of the carriage travel, do the following:

1. Hold the carriage to the right.
2. Push the rear of the clutch lever to the left, almost to the latching position.
3. The rear of the clutch latch should clear the upright lug of the clutch lever by $1/64$ " to $1/32$ ", as illustrated.

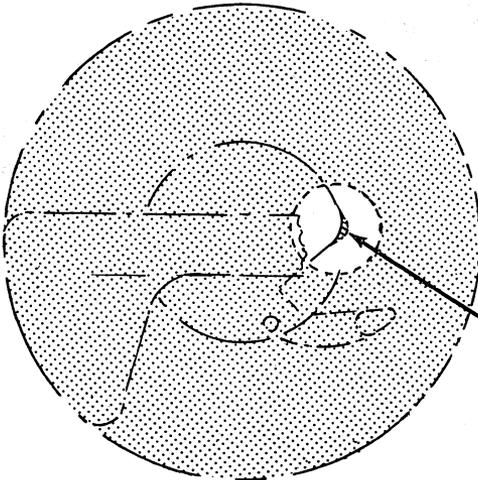
MODIFICATION OF RIGHT HAND PLASTIC RIBBON SPOOL

The hub of the spool has been relieved in the area on which the sensing finger rides just prior to entering the gate. This will cause the gate to be forced open insuring ribbon reverse. Former style spools may be similarly relieved with a pocket knife (see illustration).

Lined Area Has Been Removed

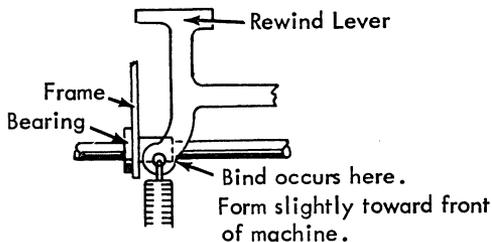
CHECK FOR REWIND LEVER BINDS WHEN INSTALLING NEW STYLE RIBBON FEED AND REVERSE SHAFT BEARING

When the new type L.H. ribbon feed and reverse shaft bearing P/N 1118191 is being installed, it may be necessary to slightly form the rewind lever P/N 1118300 away from the new bearing. The rewind lever may bind on the bearing, causing rapid rewind back to the right (see illustration).

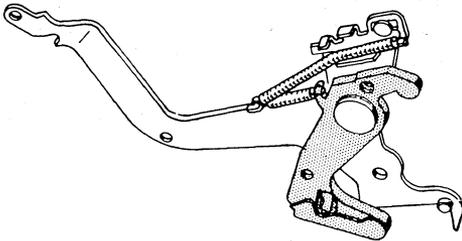
TRIP LEVER SPRING COMING OFF - TYPAMATIC OPERATION

Try installing a Model 01 typebar spring, P/N 1090341, cut to 1 1/2" to 1 5/8" long, as illustrated.

Remove the regular trip lever spring, P/N 1105906, before installing the longer spring. Caution: A change in touch will result if the new spring is too short.

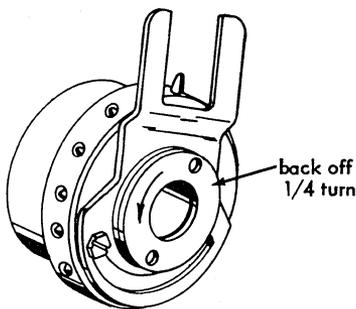
PIN FEED PLATEN - PINWHEEL BINDS

Sometimes binds occur in the pins of the pinwheel assemblies, Part Numbers 304781, 304782, 1107537, and 1107538. These binds may often be overcome by loosening the inner plate, as illustrated.

This plate is threaded and may be backed off 1/4 turn with gas pliers to open up inside clearances in the assemblies. Caution: Do not remove this plate from the assembly as it is difficult to replace.

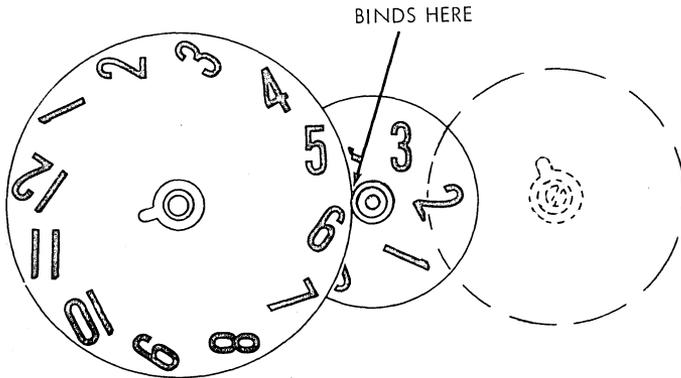
Intermittent loss of time is often the result of the plastic hours disc binding under the tens disc retaining flange.

This obscure trouble is eliminated by reducing the diameter of the hours disc by approximately $1/32$ ". A file or abrasive paper may be used for this purpose (see illustration).

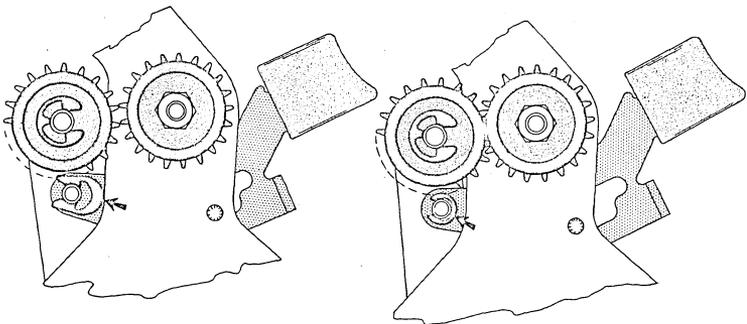
CARBON RIBBON SLIPS THROUGH FEED ROLLERS

The carbon ribbon release arm stud has been modified to accept a smaller C clip, P/N 219633. The former style larger clip may contact the magazine plate, preventing proper engagement of the feed rollers (see illustration). Installation of the smaller clip will require replacement of the release arm, P/N 1117793.

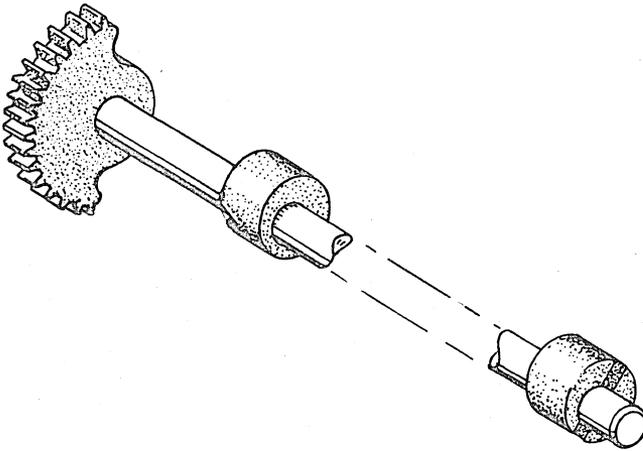
Effective with approximate Standard serial #1406935 and Executive serial #2072562, the impression control shaft (P/N 1115080) has been modified as illustrated. This does not effect the settings of the impression indicator and is interchangeable with the former style.

A spring washer, P/N 1117026, has been added between the impression indicator, reference 219-9, and the resilient keyboard indicator, reference 219-8, to prevent the impression indicator from creeping. Add this part number to pages 24 and 50 of the Model C Parts Manual.
