April 19, 1982

SUBJECT: Modification of Female Keyboard Connector

581-228-SB1

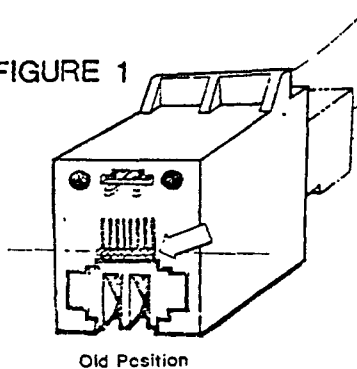
FIGURE 1

1. Turn system off and unplug A.C. cord.
2. Following Level 1 Procedures, remove the P/S Sub-Assy. from the main-frame.
3. Reinstall keyboard in C.P.U. board.
4. Viewing female keyboard connector from the rear, with the keyboard male connector installed, note the position of the contacts as they protrude through the rear of the female connector (See Fig. 1). (Contacts should be near the bottom of the alignment channels, protruding approximately $3/64$ of an inch).
5. Using a spring hook, lift each contact individually and reform the contact to insure that in its home position with keyboard connected, the ends of the contacts appear as in Fig. 2.

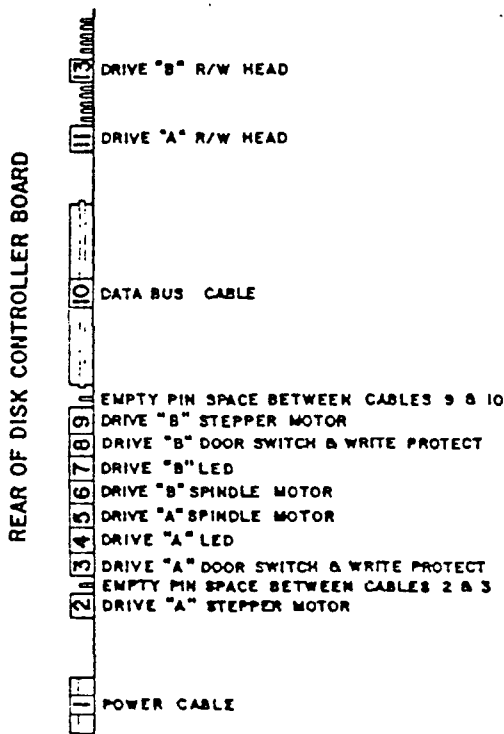
FIGURE 1
PART # X-100093

WHEN REPLACING AN OLD STYLE DISK DRIVE BOARD (PART # X-100093) WITH THE NEW STYLE DISK DRIVE BOARD, (PART # X-100670) THE CONNECTORS MUST BE RECONFIGURED. THE NEW STYLE BOARD IS DISTINGUISHED BY THE ADDITION OF A 4 PIN CONNECTOR (J19). J19 IS LOCATED ON THE RIGHT SIDE OF THE BOARD AS VIEWED FROM THE FRONT OF THE UNIT. THE CONNECTOR CONFIGURATIONS ARE AS FOLLOWS:

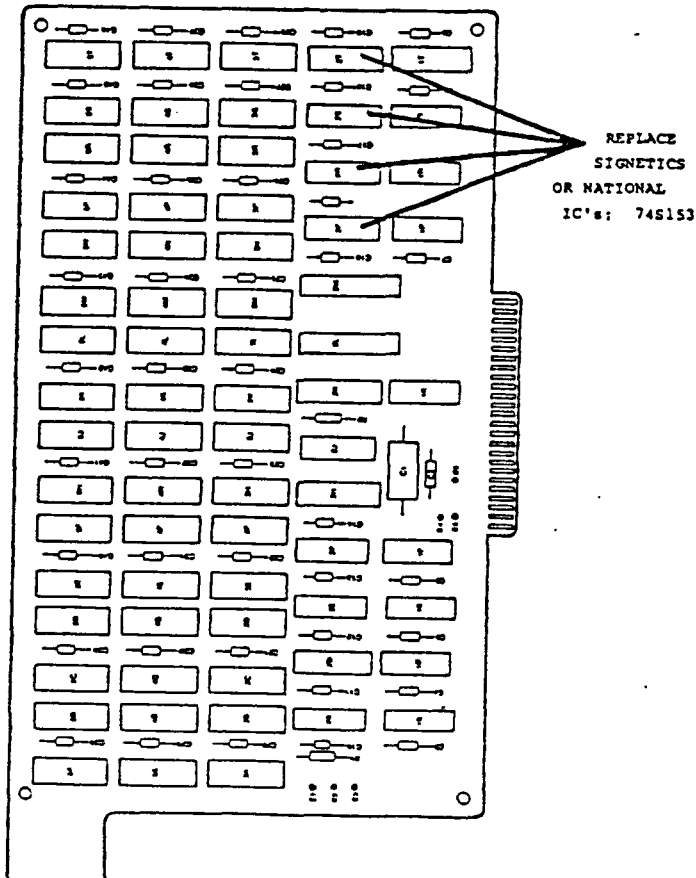
384K MEMORY BOARD

SUBJECT: 384K RAM MEMORY BOARD FAILURES

Ram memory board failure may be caused by Signetics or National ICs (74LS153). Replace the National or Signetics ICs in locations 2P, 2R, 2S, and 2T with:

The figure shows IC replacement locations on the PCB.

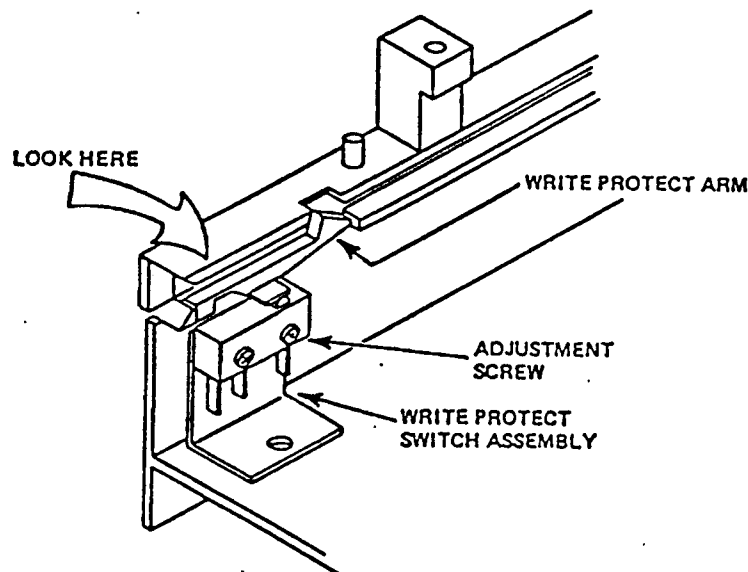
Write Protect Switch Assembly Arm and Adjustment Screw

Failure of the door or write protect switch may occur due to oxide formation on the contacts.

WRITE PROTECT SWITCH FAILURE: System prompts with "DISK WRITE PROTECTED", when there is no write protect tab on diskette. Possible "FC" error.

- 1) Visually ensure that the arm on the Write Protect Switch assembly moves the switch and makes a clicking noise when the arm is pushed down.

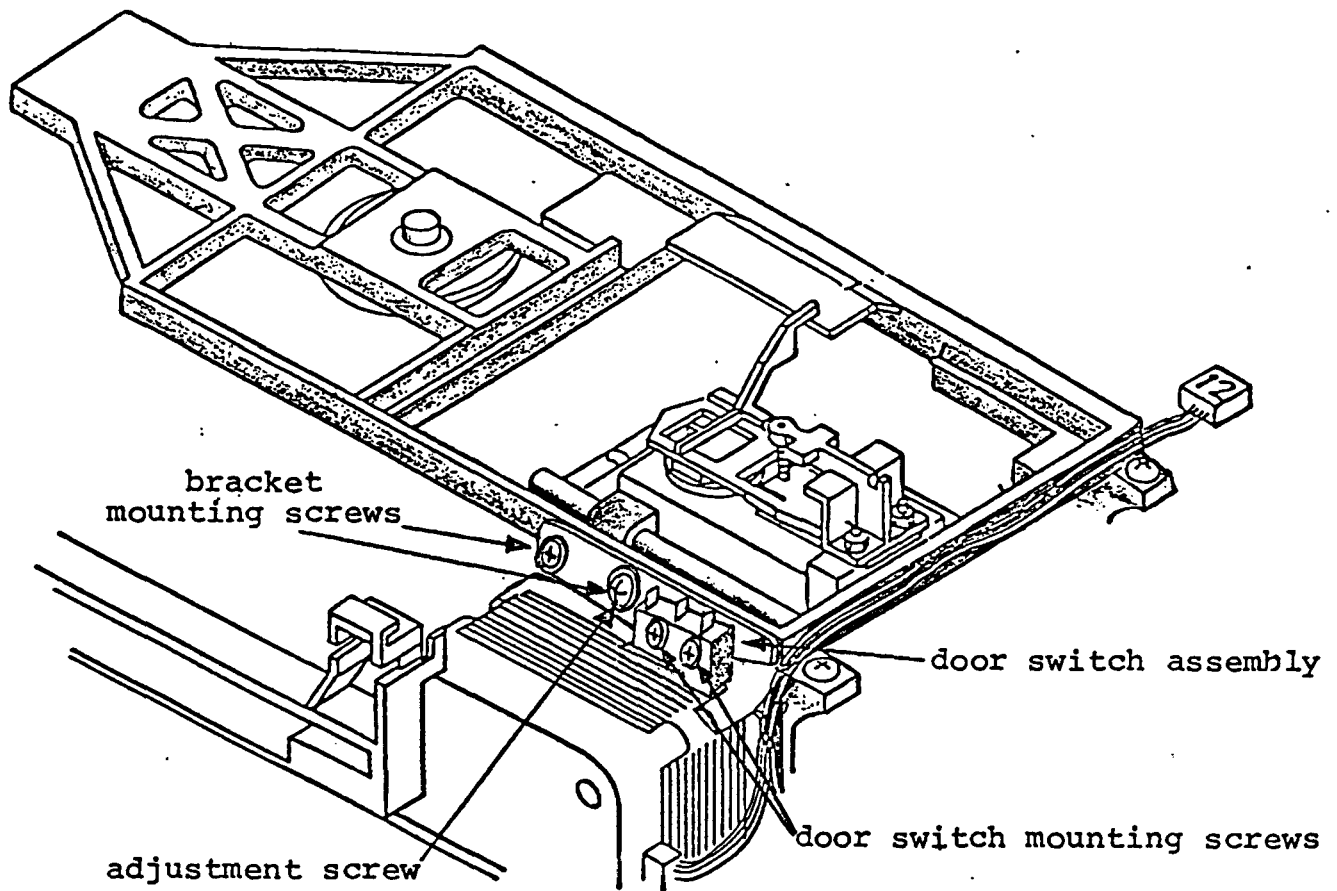
Symptoms: DOOR SWITCH FAILURE: System will not boot when door is closed. Possible "FA" error (DOOR OPEN).

- 1) Remove the defective drive.
- 2) De-solder the two wires which go to the door switch. *Note: Wires should be connected to same terminals they were removed from.
- 3) With a Phillips screwdriver, remove the two mounting screws which hold the door switch to the door switch mounting bracket and detach the switch.

- 4) Install new switch and adjust, if necessary, by loosening the bracket screw farthest to the back of the drive and pivoting the switch up or down. The switch should engage when door is half-way closed. Listen for a slight "click" which signifies switch is engaged. Tighten adjust screw.

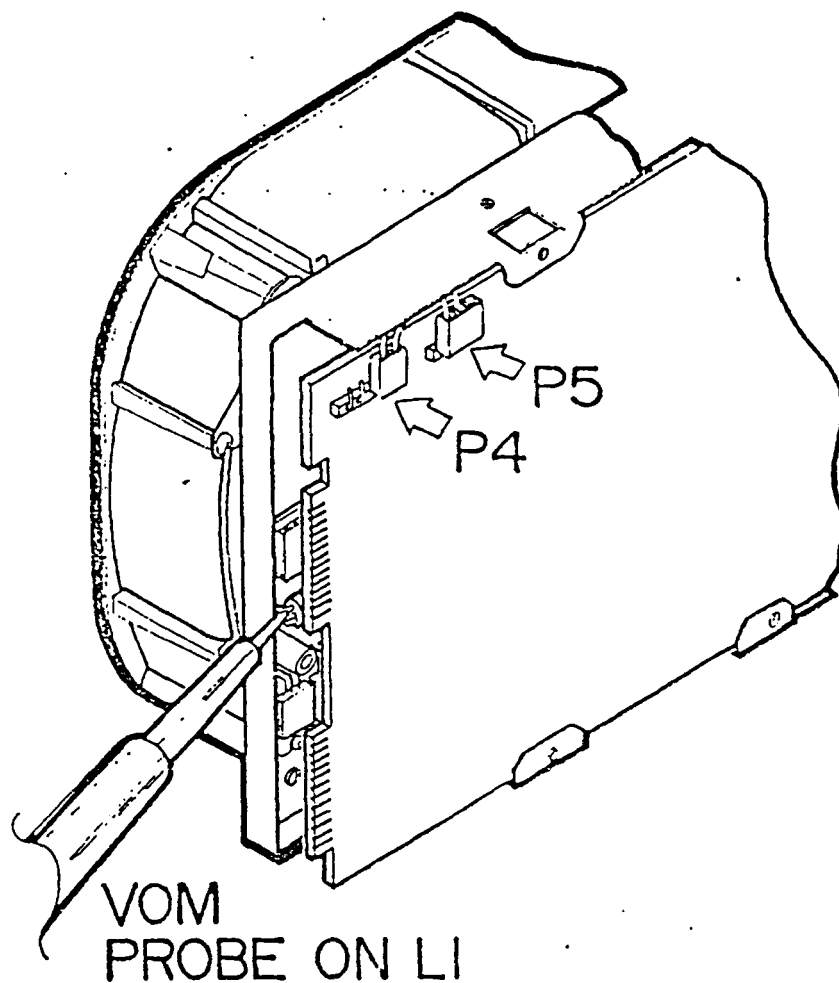
FIGURE 1

Recent failure studies indicate the possibility of bad crimps on P4 (+12V to spindle) and/or P5 (index signal) connectors on the Tandon TM600 Main up Board.

NOTE: Any variation from step 2 warrants examination of P5 connector for improper crimps as outlined in step 3. Proceed to P4 connector if no variations exist.
