ANALYSIS GUIDE SERVICES INDEX

IBM Customer Engineering

Selectric I/O Printer

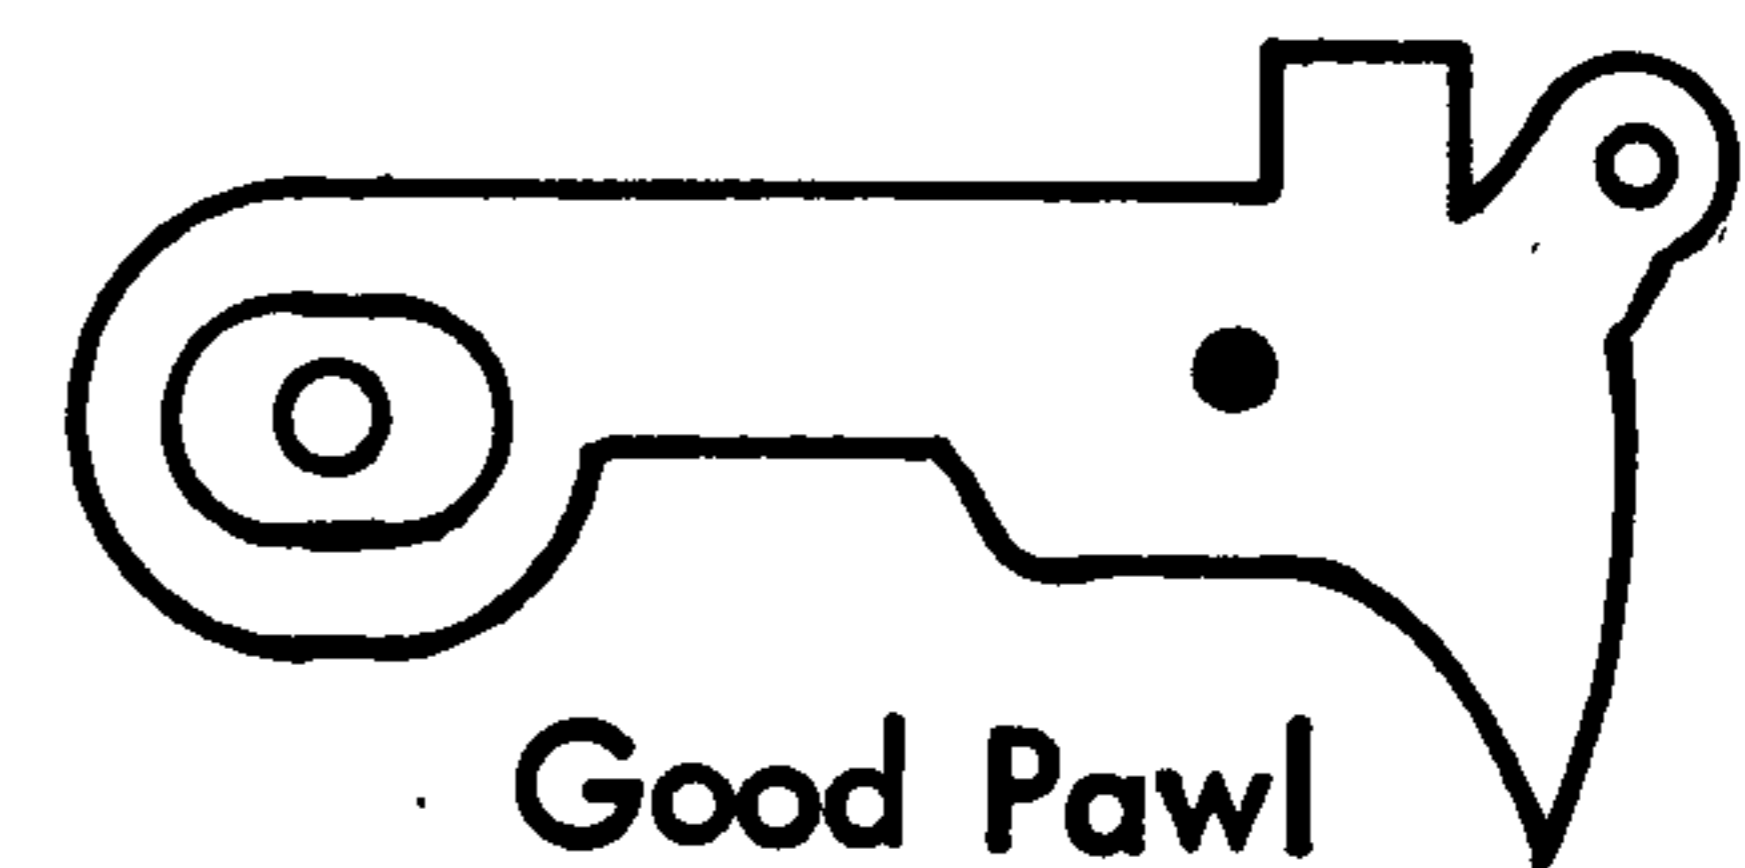
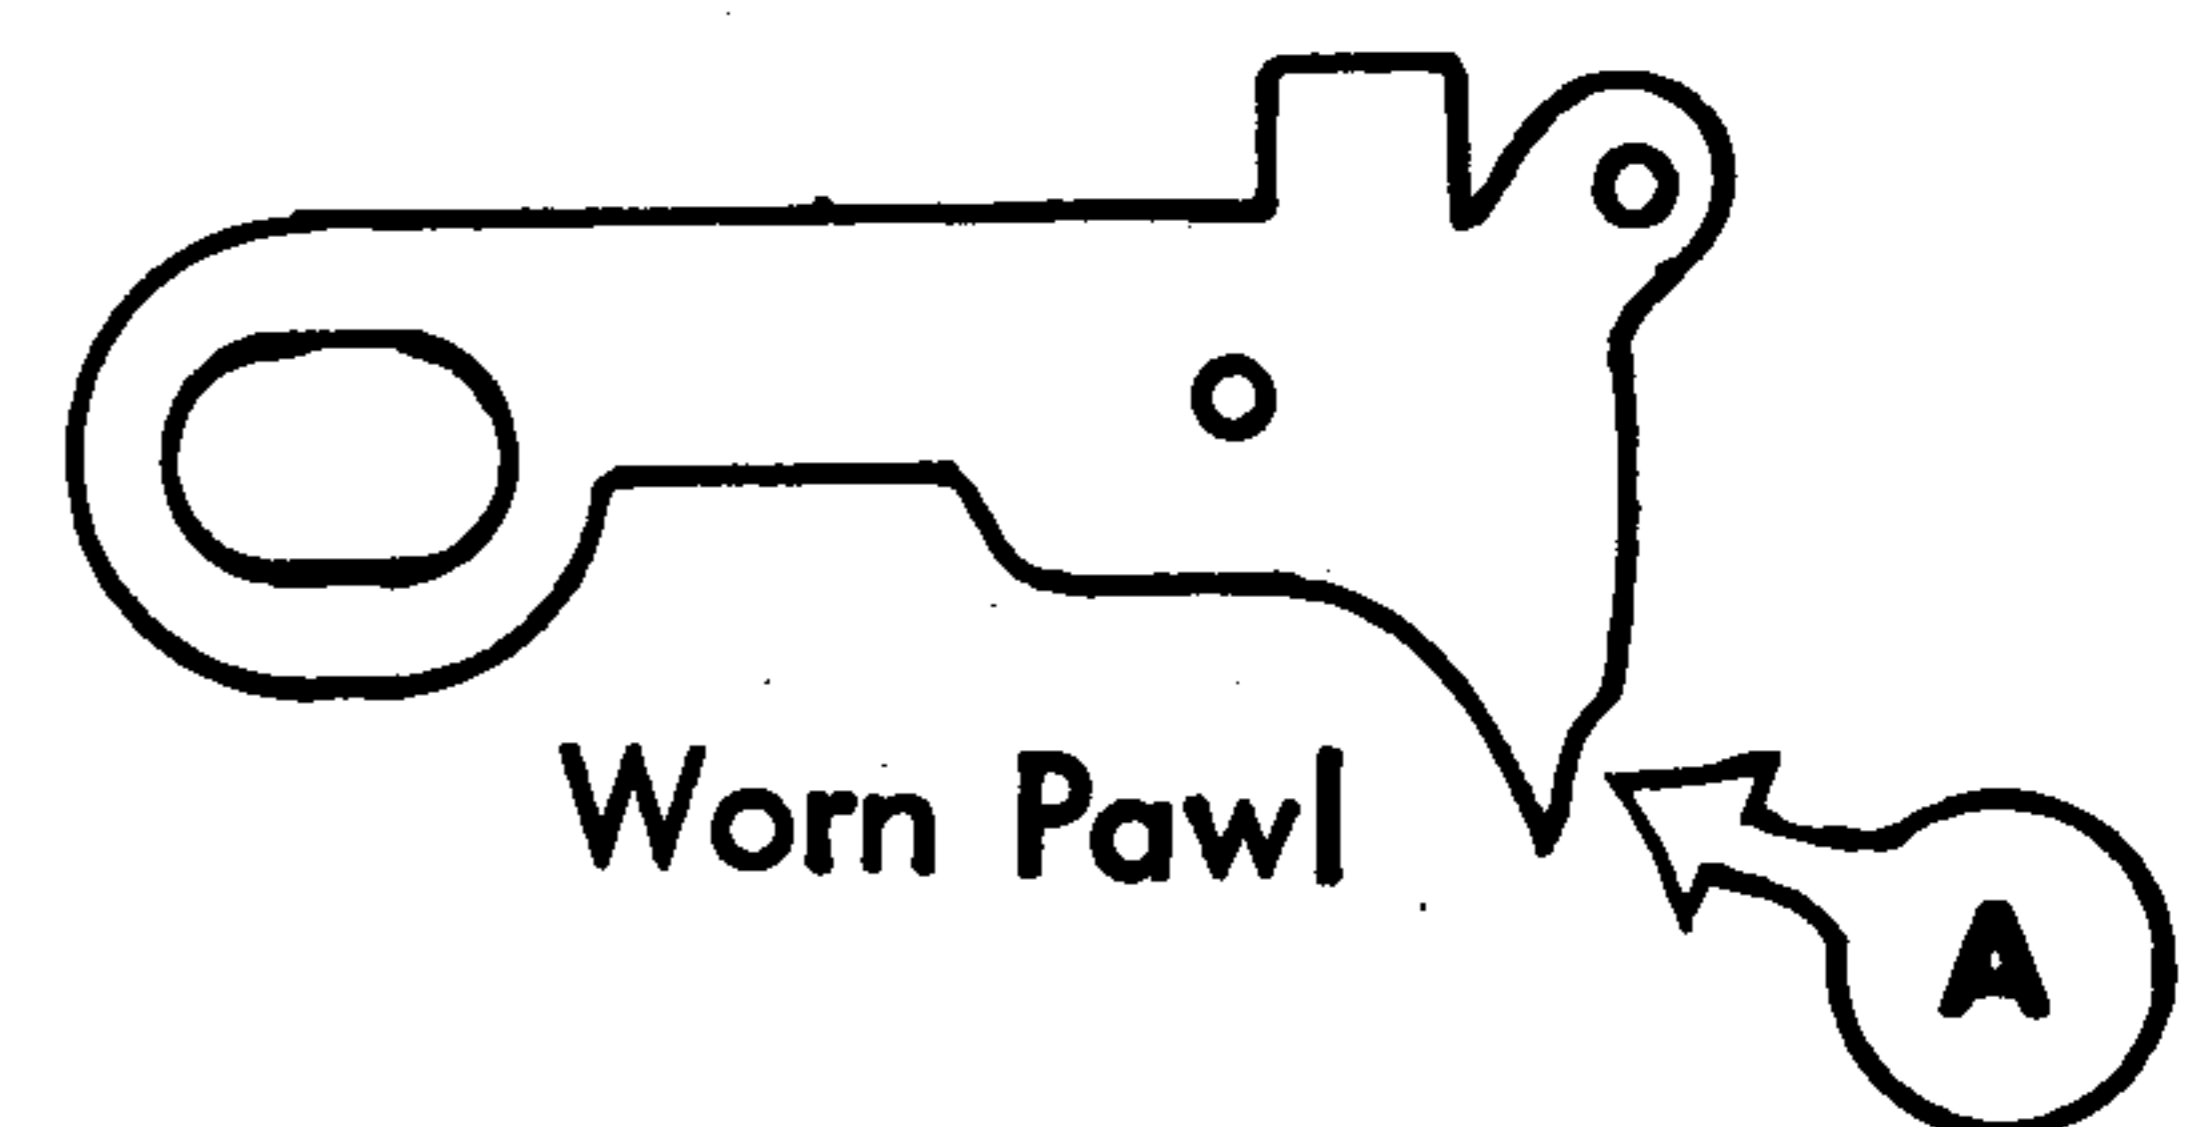
FIG. 3.1

A worn pawl will be notched and polished at point "A".

- a. The Clutch Unlatching Link being too short.
- b. The overbank adjustment.
- c. A worn Escapement Pawl. (Fig. 3.1)

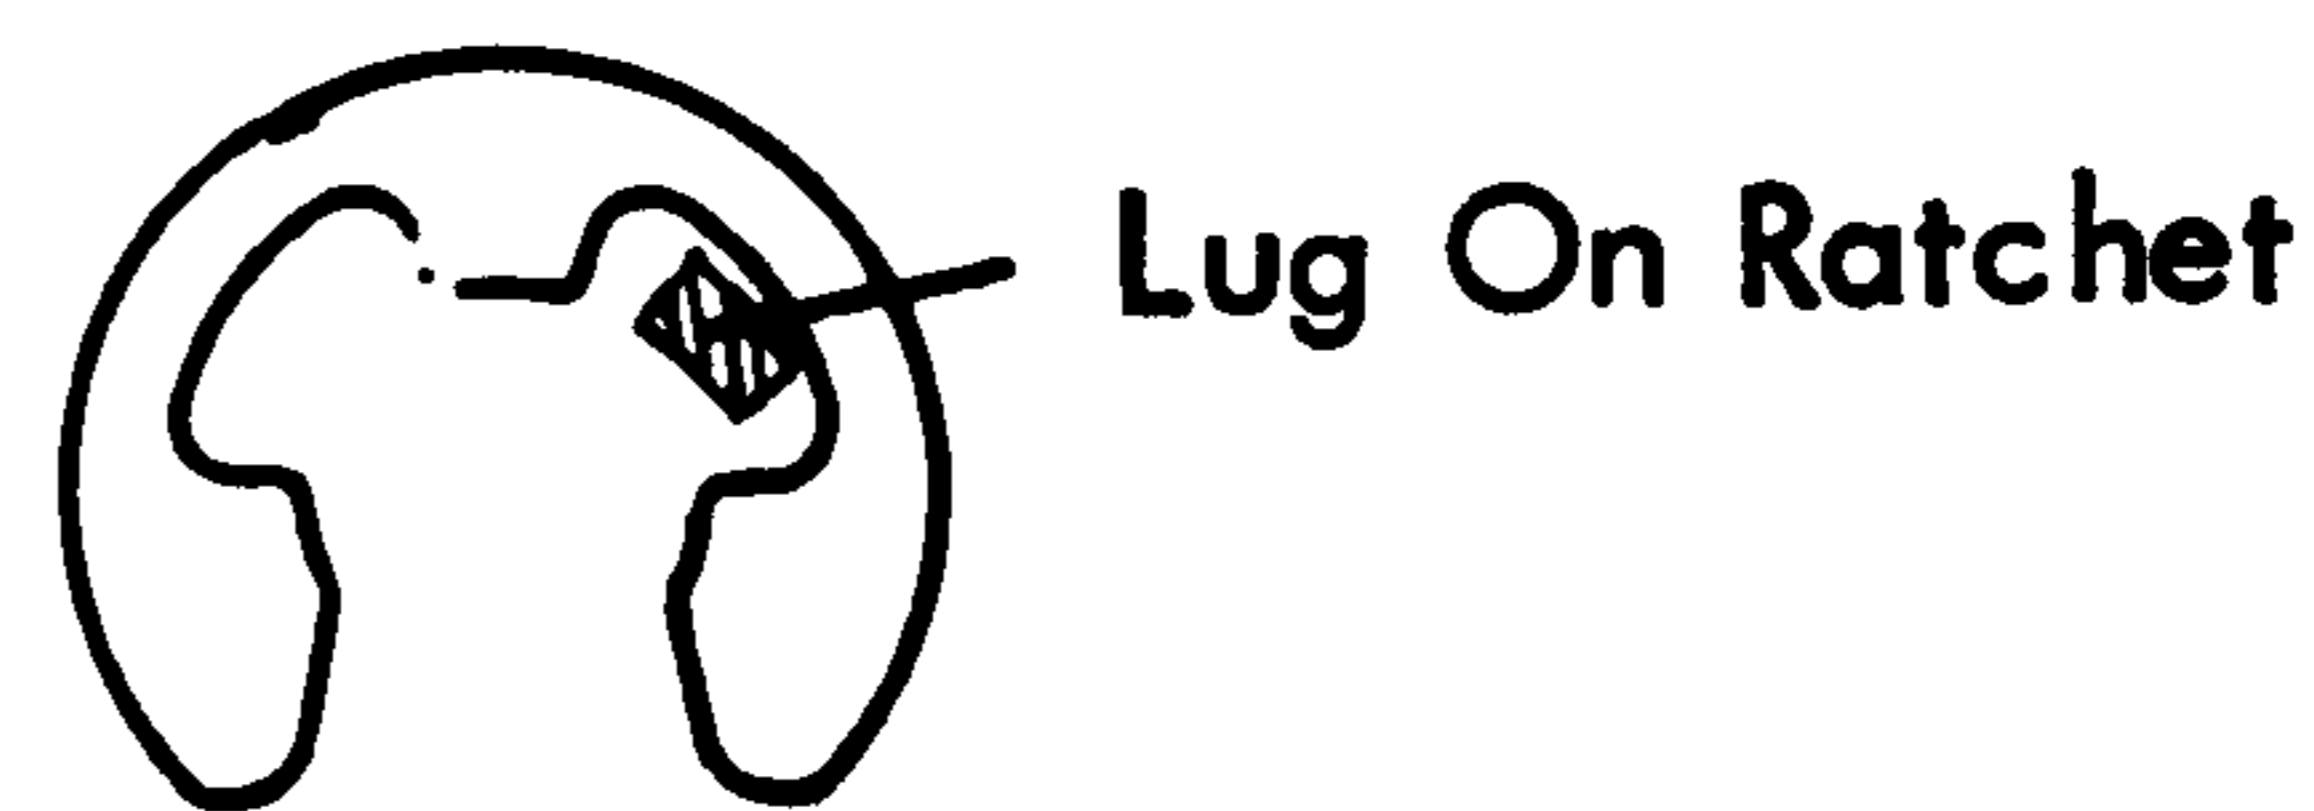
FIG. 4.1

- 4.7 The "C" clip must be inserted so that the lug that extends from the ratchet is in the "C" clip window as shown in Fig. 4.1.

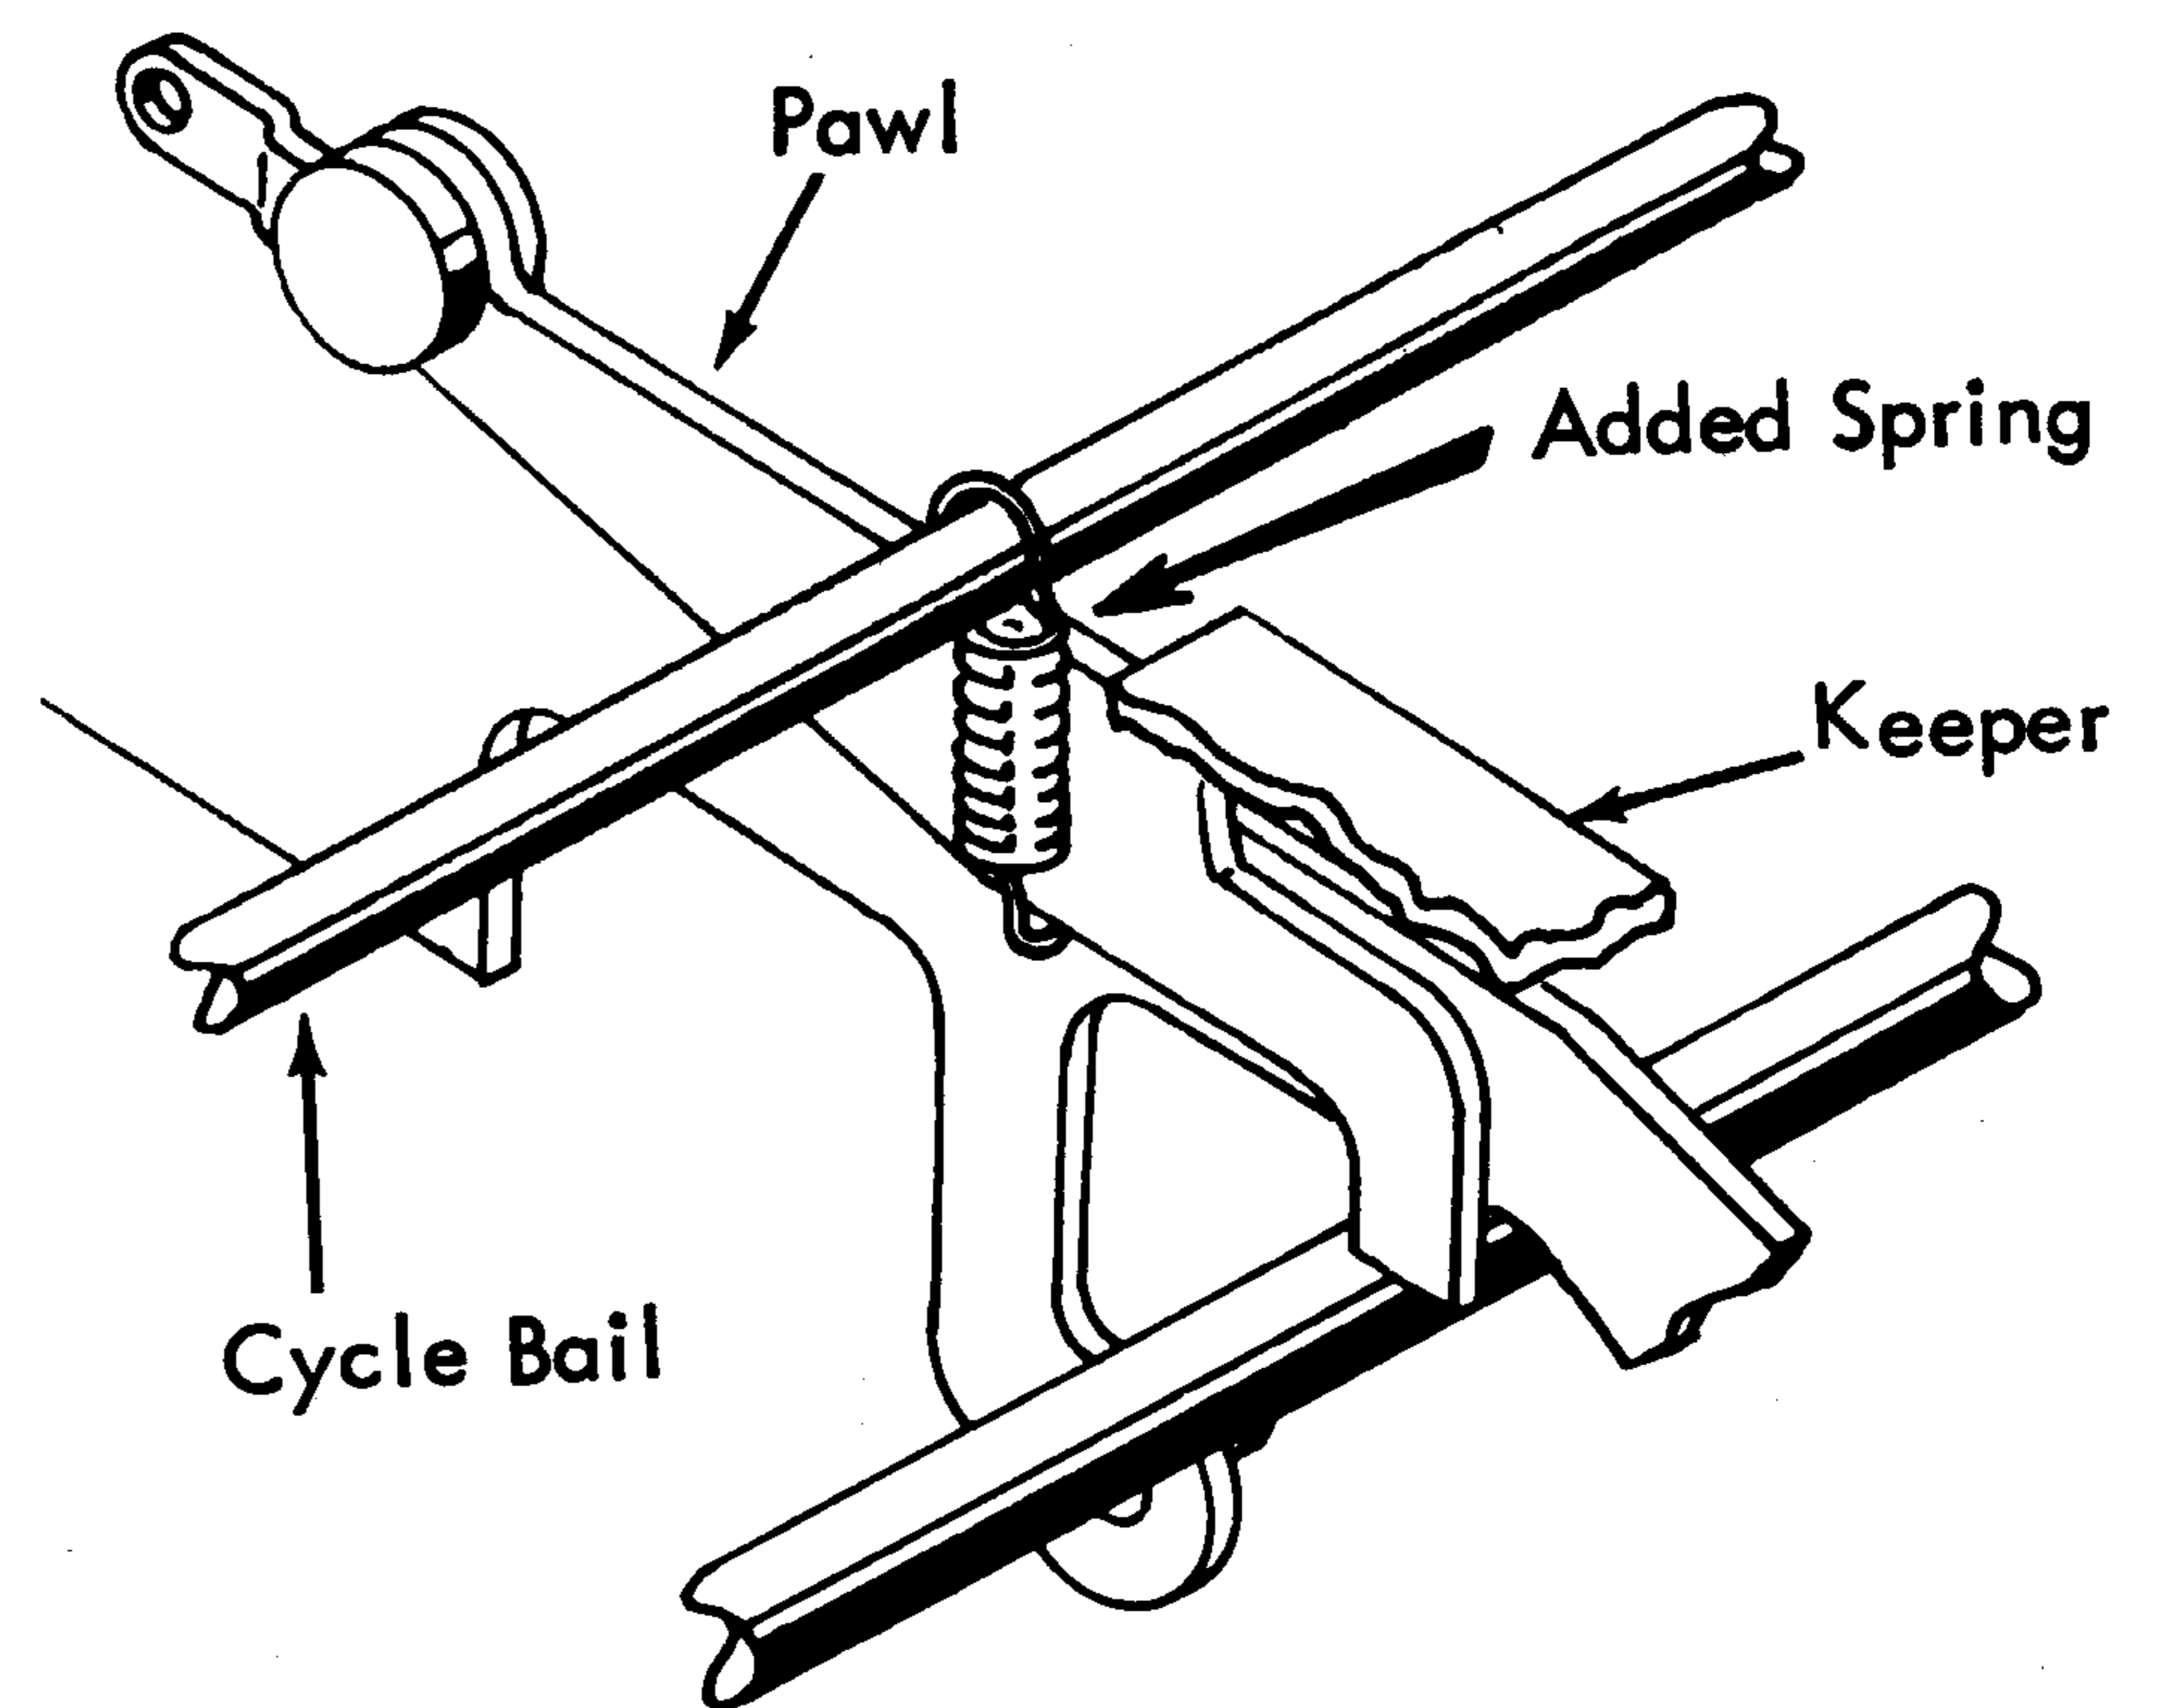
FIG. 12.1

Pawl bite should not exceed $\frac{1}{2}$ the thickness of the keeper. Adjust the cycle bail upstop. This will maintain a clearance of .010" - .020" between the cycle bail and the interposers. With this clearance the cycle bail will not be able to bounce on the interposers.

A spring P/N 1090343, may be added between the cycle clutch trip bail and the cycle clutch pawl to reduce bail bounce. (Figure 12.1.)

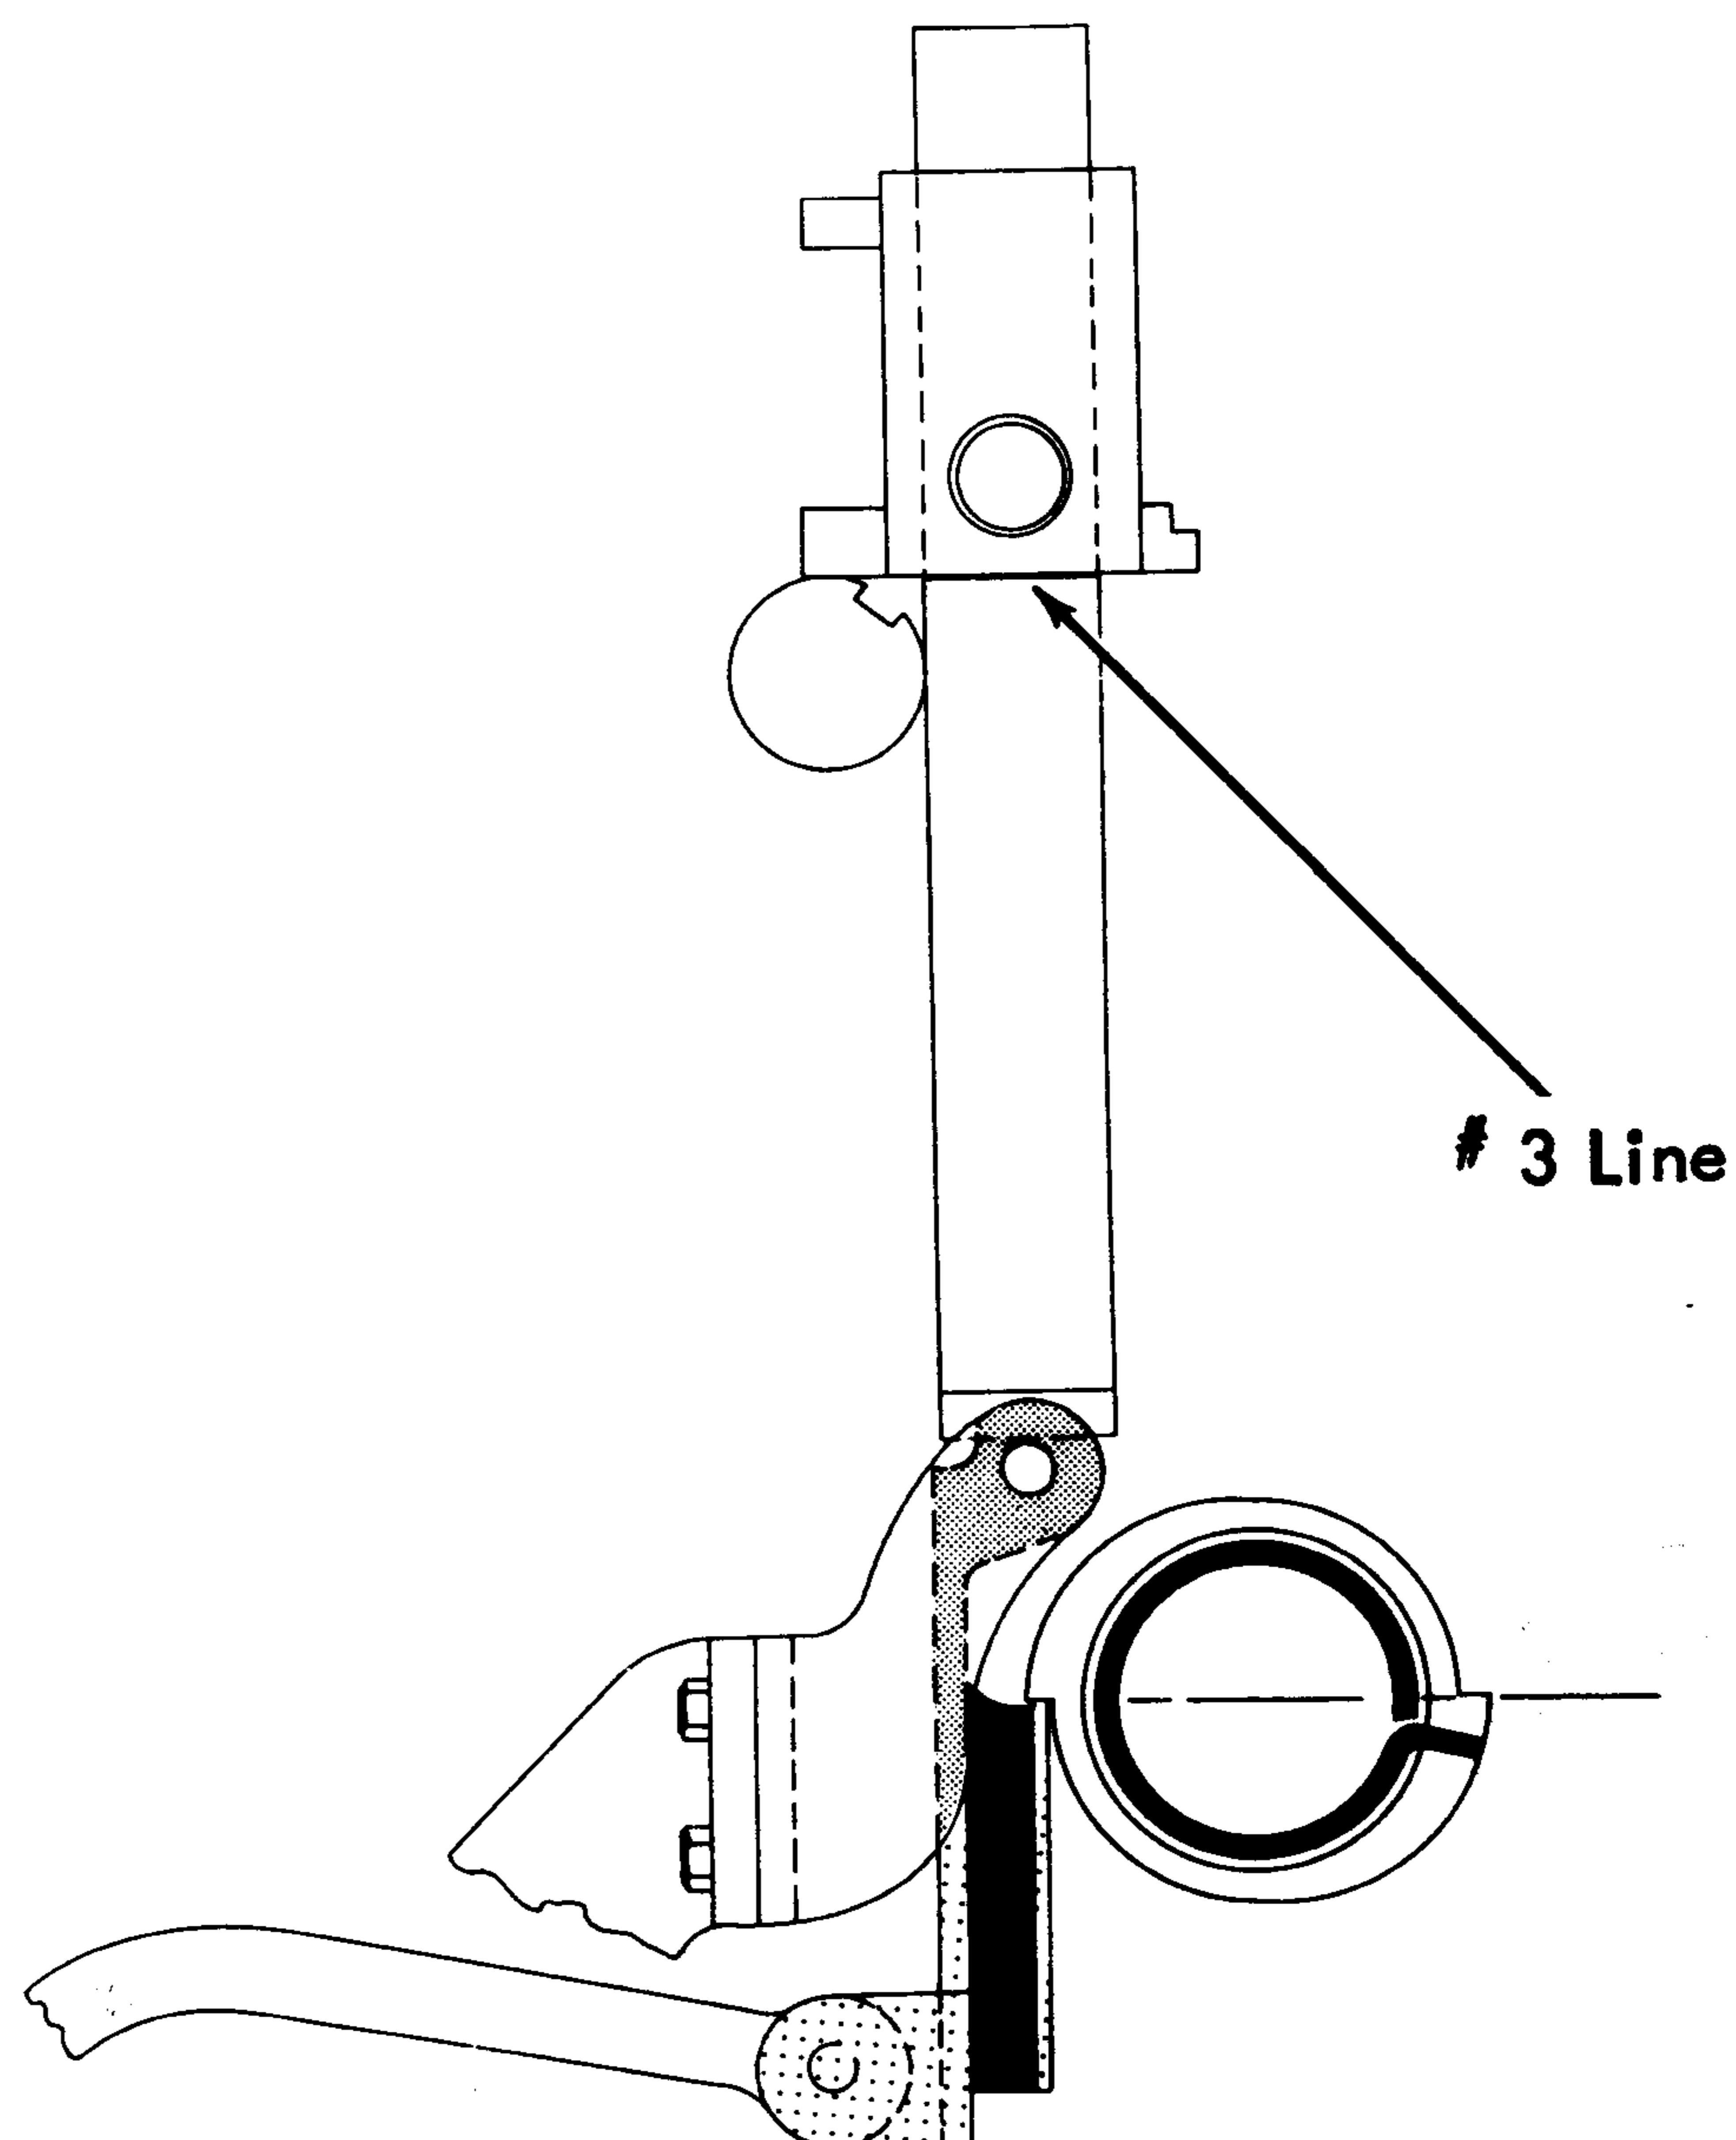
FIG. 15.1

The cycle clutch latch height must always be checked before attempting cycle clutch collar adjustment (*Fig. 15.1*). If the latch is too high, extra cycles may occur. If the latch is too low, the cycle clutch may not unlatch.

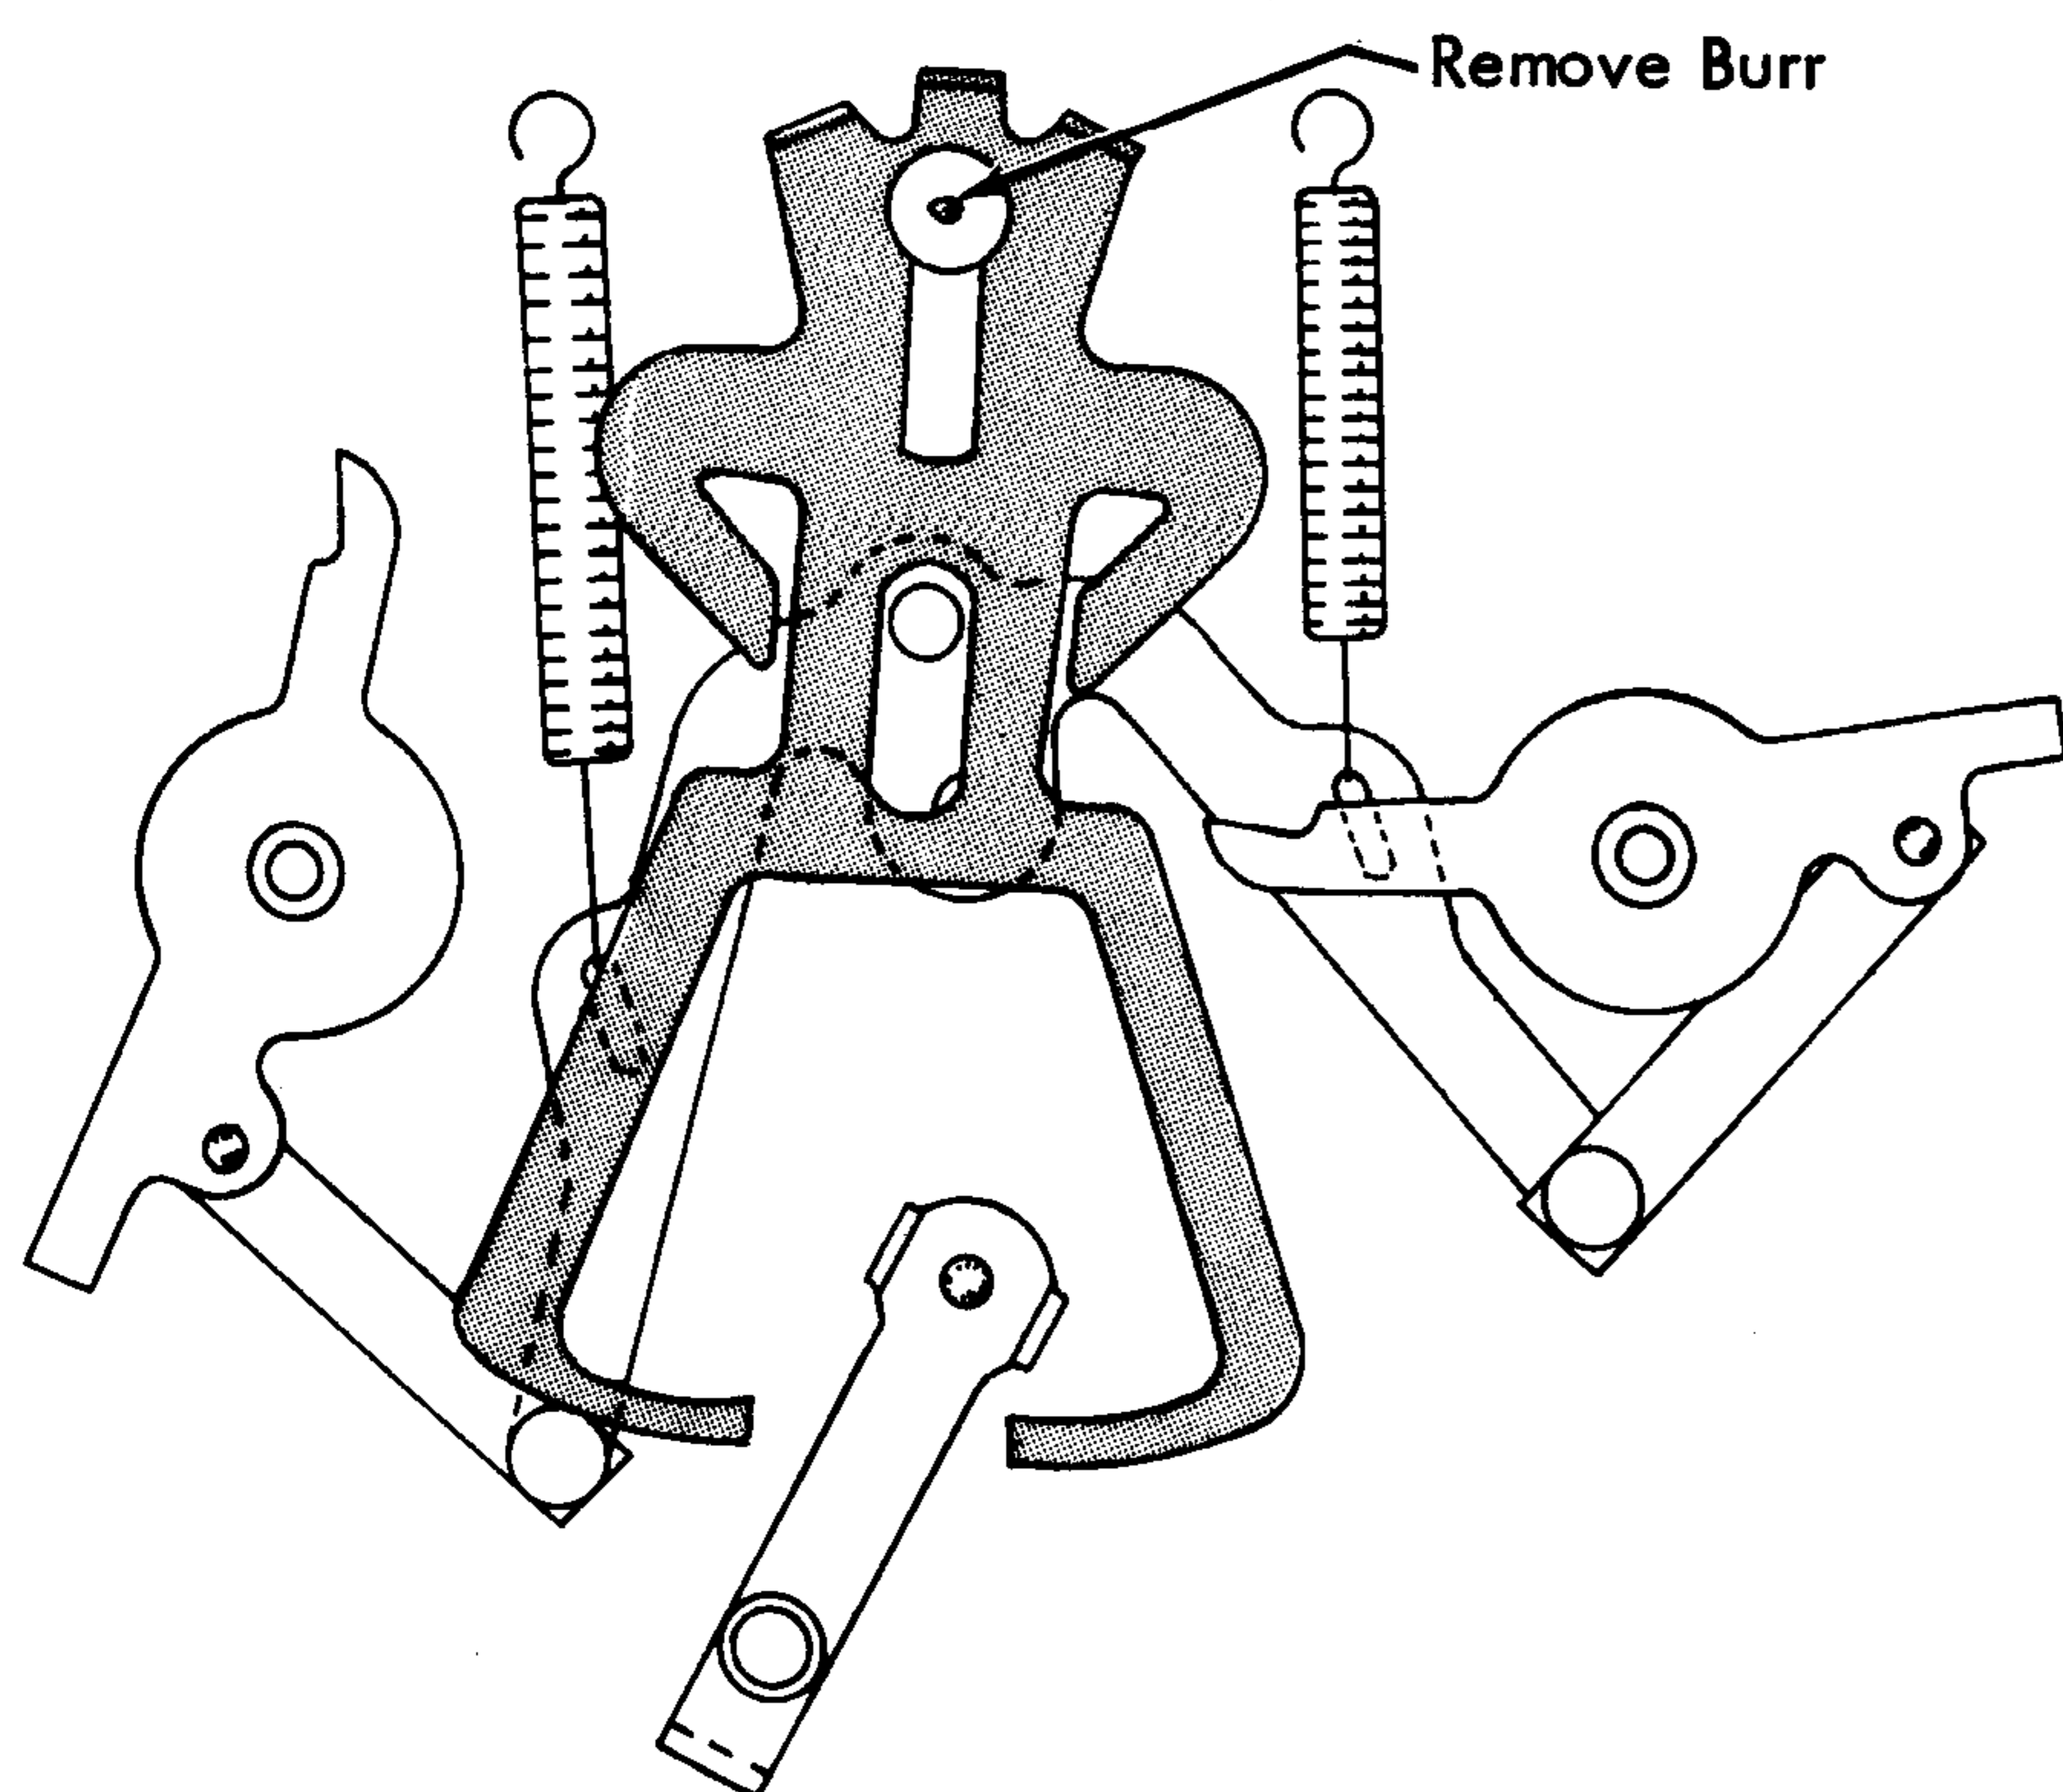
FIG. 20.2

20.6 RIBBON REVERSE FAILURES

- a. Form the Reverse Trigger Springs down to increase their tension.
- b. Check for a burr on the top of the Reverse Interposer Rivet. File the burr off.

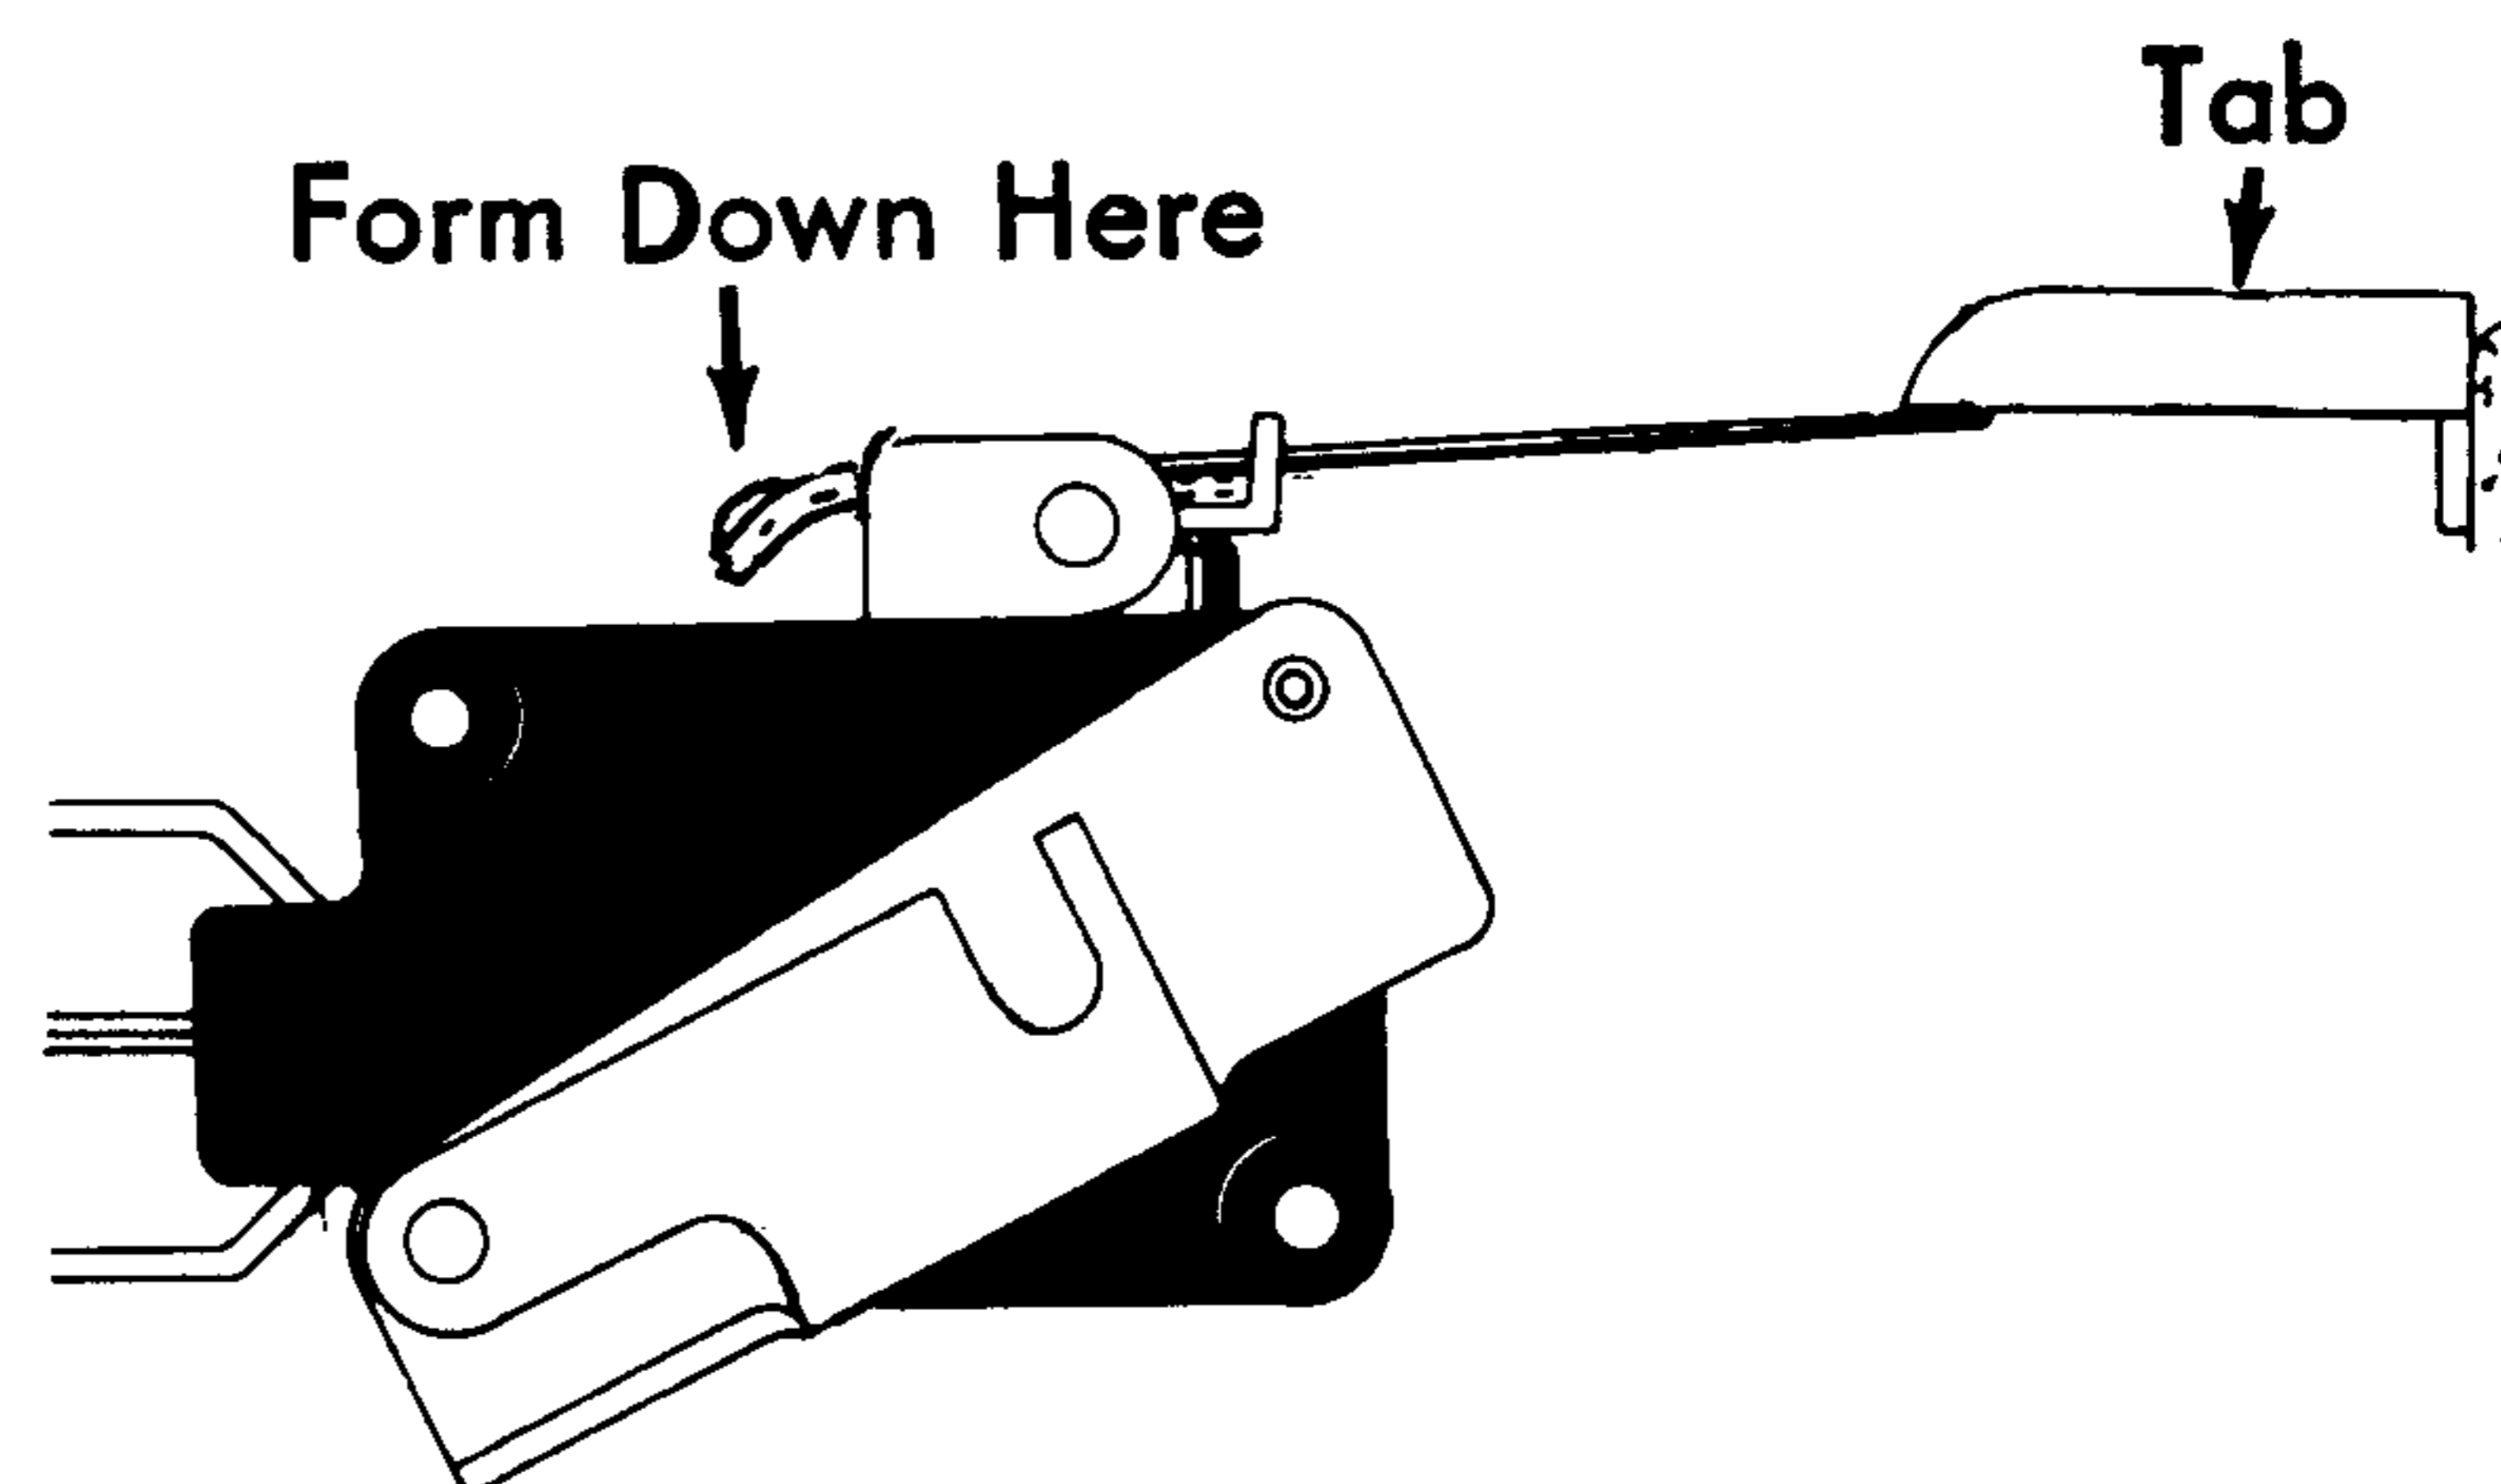
FIG. 22.1

If the actuating wire pops out from under the torque bar actuating arm, form the rear section of the actuating wire to provide an overthrow stop for the wire (Figure 22.1.) See the I/O Printer Reference Manual for the specific adjustments.
