RK8-E Handouts

RK05 Reference B938

digital	FIELD SERVICE TECHNICAL MANUAL				Option or Designator
	12 Bit <input checked="" type="checkbox"/>	16 Bit <input checked="" type="checkbox"/>	18 Bit <input type="checkbox"/>	36 Bit <input type="checkbox"/>	RKØ5

Title +5 VOLT REGULATOR 5409503				Tech Tip Number RKØ5-TT-1	
All	Processor Applicability			Author J. WALSH/A. MUIR Rev Ø	Cross Reference
	8	11		Approval HAROLD LONG Date 9/12/72

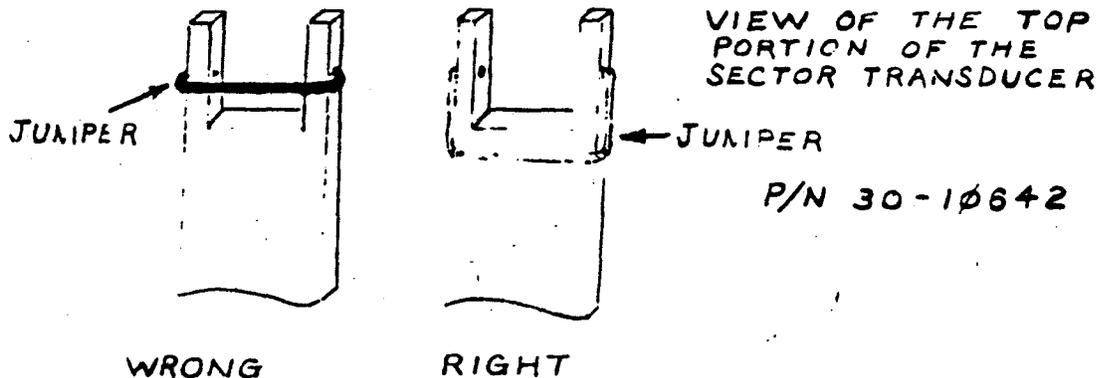
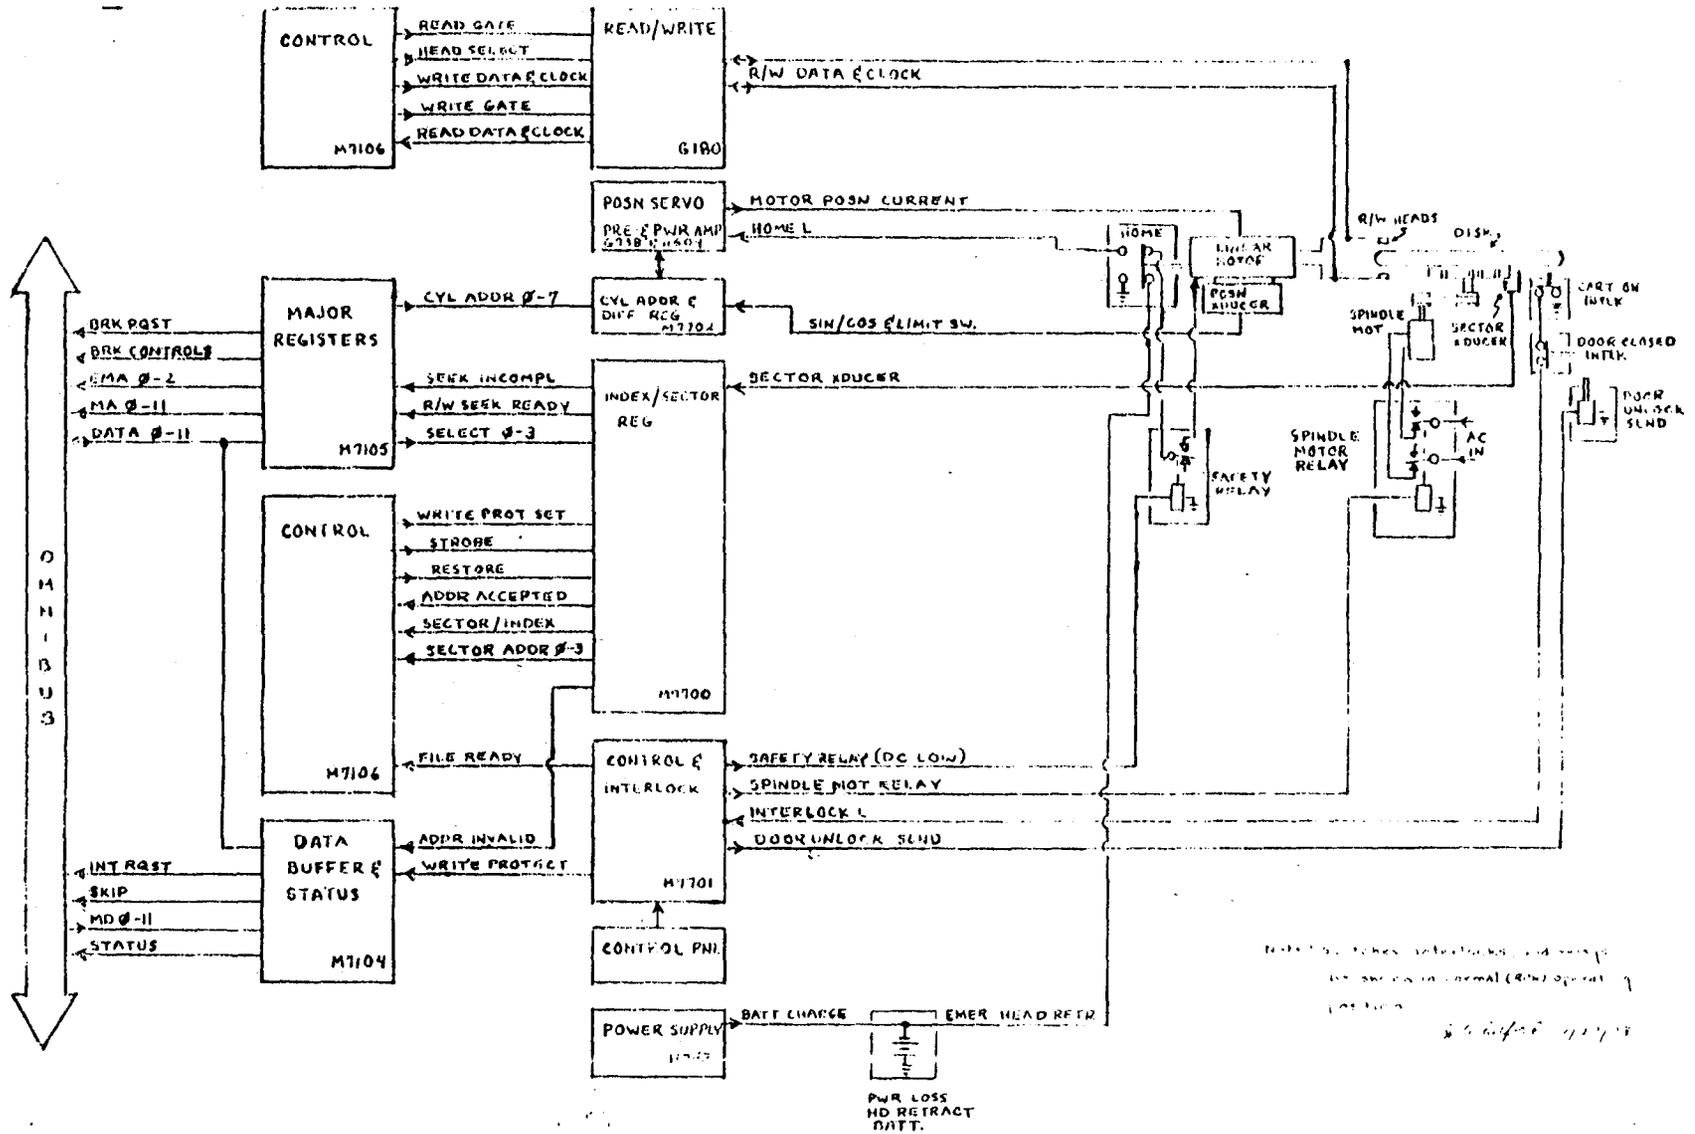
Title IMPROPERLY WIRED SECTOR TRANSDUCERS				Tech Tip Number RKØ5-TT-2	
All	Processor Applicability			Author J. WALSH/A. MUIR Rev Ø	Cross Reference
	8	11		Approval HAROLD LONG Date 9/12/72

A number of improperly wired sector transducers were produced some time ago. We feel that our logistics system has been purged of these defective parts, however, as a precautionary measure, this tech tip is being issued. Below, both types of transducers are illustrated. Should replacement become necessary, it is suggested that a visual inspection be made. Improperly wired transducers should be disposed of and replacement ordered from Maynard or respective regional stockrooms.

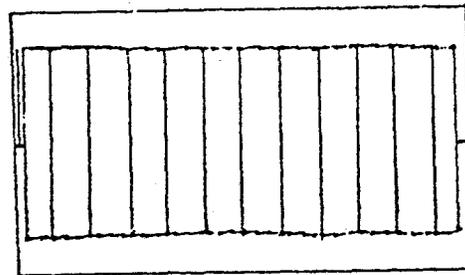
Figure 1
Negligible runout

An additional feature of the alignment cartridge is its ability to indicate the degree of runout of the spindle. By triggering the oscilloscope on INDEX and displaying a complete revolution of the disk on the display, the head may appear to be aligned at a few sector locations while misaligned at others. Such a condition is indicative of the degree of wobble of the spindle. Figure 1 shows a display with negligible runout while Figure 2 shows a spindle with considerable runout. The amount of wobble can be determined by the amplitude differences occurring in any adjacent pair of sector boundaries by the same equations as used for head alignment. The acceptance criteria for spindle runout is to be determined.

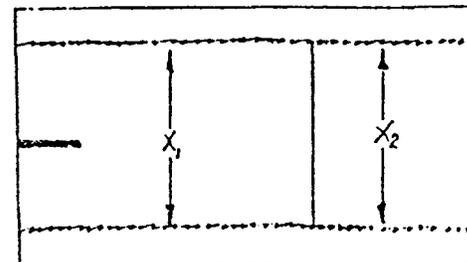
d. Right On

Head correctly aligned at CYL 105. Amplitudes are equal.

- Loosen the clamp and adjustment screws (Figure 10) and move the head in the appropriate direction until the "right on" waveform is obtained and the scale indication is slightly greater than 105.

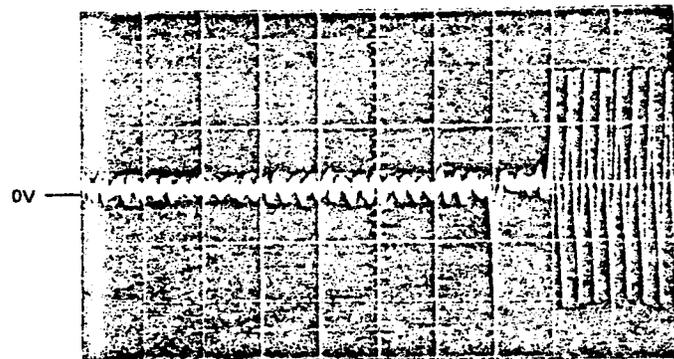
Figure 4 Index/Sector Waveform

PIN = TP3&TP4
 SWEEP = 10 us/div
 VERT SENS = 0.2V/div

13. If R6 does not adjust the average of the two pulses to 70 usec, perform the following:
- Loosen the sector transducer screws.
 - If the average of the pulses is greater than 70 usec, move the transducer towards the airduct, if less than 70 usec move transducer away from the airduct.
 - Tighten the screws and perform steps 11 and 12.
14. If the time between the two pulses is greater than 20 usec, one or possibly both of the heads must be replaced. DO NOT BEND THE HEADS. The head to be replaced can only be found by trial and error.
