CUSTOMER ENGINEERING

NEWS LETTER

January 14, 1957

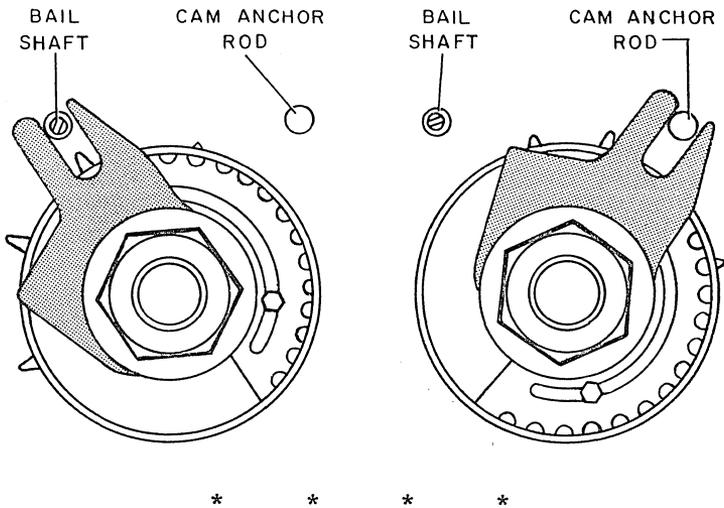
PIN FEED PLATEN

Operators using Model A and Model B pin feed attachments occasionally desire to change quickly from a pin feed form to a non-pin feed form without changing the platen. This may be accomplished by adjusting the pin wheels for full extension in the form when the pin feed yokes are on the bail shaft. The yokes may then be moved back to the cam anchor rod when it is necessary to type a non-pin feed form.
