TO: ALL CUSTOMER ENGINEERS

The attached News Letter is intended to replace all News Letters issued since the announcement of the Model C in January, 1959. All information considered pertinent at this time has been grouped by mechanism for your convenience. This should be particularly helpful to new Customer Engineers who have not received back issues of News Letters.

TABLE OF CONTENTS

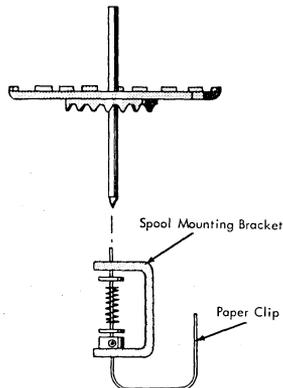
INSTALLING FABRIC RIBBON B/M #1271296 (CEM #527)

The following technique has been suggested for holding the spring, collar, and washers while inserting the ribbon spool drive plate shaft.

1. Open and form a paper clip (see illustration).
2. Insert formed clip through bottom hole in the ribbon spool mounting bracket.

3. Place collar, washer, spring, and second washer on paper clip. This will maintain alignment while the drive plate is inserted.
4. Gradually withdraw the paper clip while inserting the drive plate shaft.
5. Install grip clip.

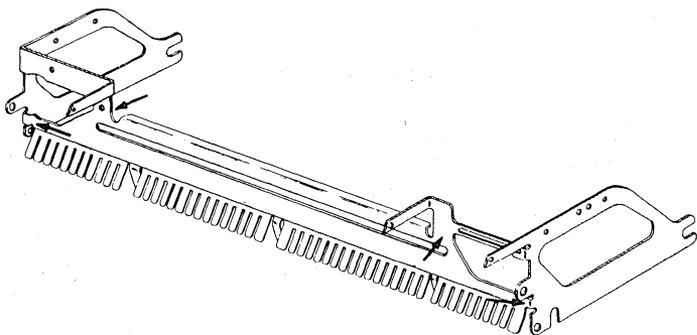
A useful tool for holding keylevers in alignment during bearing support removal can be made from a spare bearing support (part no. 1118217) as follows:

1. Cut the ends from the bearing support assembly along lines indicated by arrows in the illustration below.
2. File the cut surfaces to remove burrs and sharp edges.

By inserting this "guide comb" between the keylevers at a point immediately in front of the keylever adjusting lugs and by inserting the small fulcrum wire through the pilot hole in the keylevers (small hole to the front of pivot hole), the typewriter bearing support assembly can be removed without disturbing alignment of the keylevers. With this arrangement, it becomes a relatively simple matter to install another bearing support since the keylevers can now be reconnected to it as a unit.

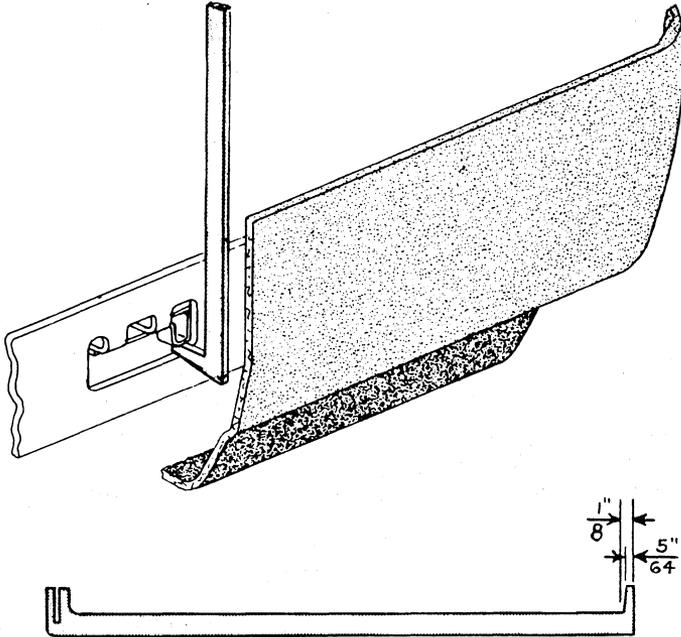
TKO BENDER CHANGE

One end of the TKO Bender, Tool #9504486, has been modified to permit its being used to adjust the spacebar adjustable spring support, P/N 1117916, on Model C Standard ET's. By placing the tool in the hole provided in the front frame, as shown in the illustration, the adjustable support can be easily formed upward. By placing tool in U portion of the support, it can be formed downward as desired without removing the bottom cover.

This tool modification can be made to your TKO Bender by grinding the tool to the dimensions as shown in the above illustration.

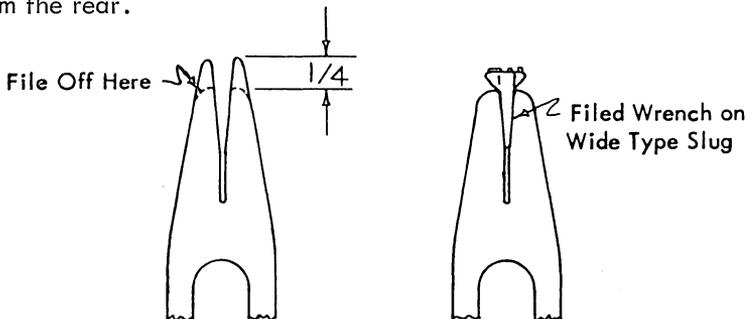
On 4 and 5-unit characters, the type face is often wider than the type slug, preventing the aligning wrench from grasping the type slug from the rear. The aligning wrench may be filed off 1/4" as

illustrated to enable the jaws of the tool to grasp these typebars from the rear.

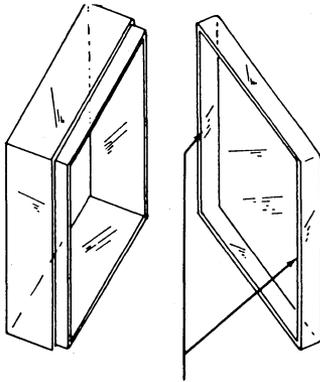
QUICK FIX FOR PLASTIC PARTS BOXES (LOOSE LIDS)

Touch these points on inside surface with soldering iron.

To make plastic parts box lids snap on securely, touch the lids with a soldering iron as illustrated. A tiny notch melted on opposite inside surfaces of the lid makes a snug, snap-on fit. Wear safety glasses when using soldering iron.

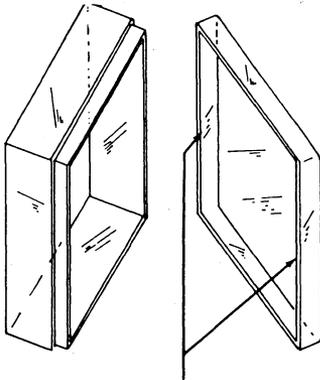
QUICK FIX FOR PLASTIC PARTS BOXES (LOOSE LIDS)

Touch these points on inside surface with soldering iron.

To make plastic parts box lids snap on securely, touch the lids with a soldering iron as illustrated. A tiny notch melted on opposite inside surfaces of the lid makes a snug, snap-on fit. Wear safety glasses when using soldering iron.
