April 19, 1982

SUBJECT: Modification of Female Keyboard Connector

581-228-SB1

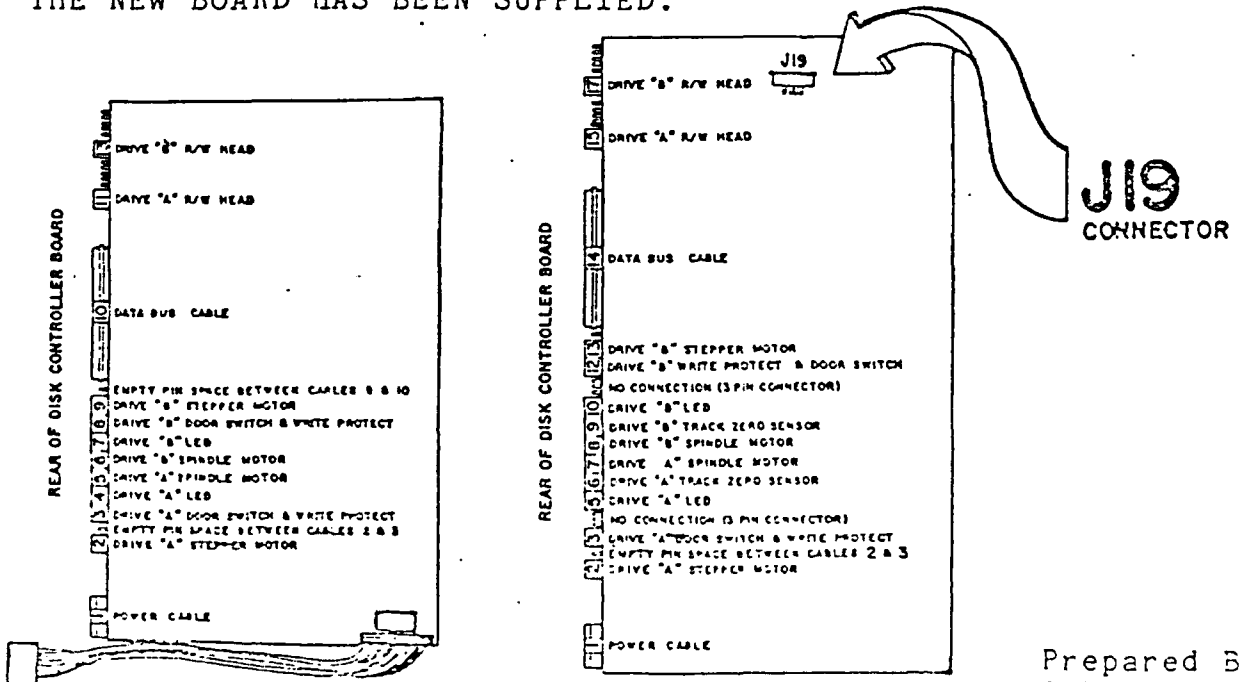
IF THE DISK DRIVE BOARD IN THE SPARES KIT IS THE OLD STYLE BOARD (PART # X-100094-01 OR X-100094-02), IT SHOULD BE IMMEDIATELY RETURNED TO THE EL PAÑO DEPOT. THE NEW STYLE BOARD (PART # X-100670) SHOULD BE PLACED IN THE SPARES KIT TO SUPPORT COMPUTER REPAIRS.

SPARES KITS SHIPPED AFTER MAY 21, 1982 MAY INCLUDE THE NEW DRIVE BOARD (X-100670) HOWEVER, CHECK SPARES KITS TO INSURE THE NEW BOARD HAS BEEN SUPPLIED.

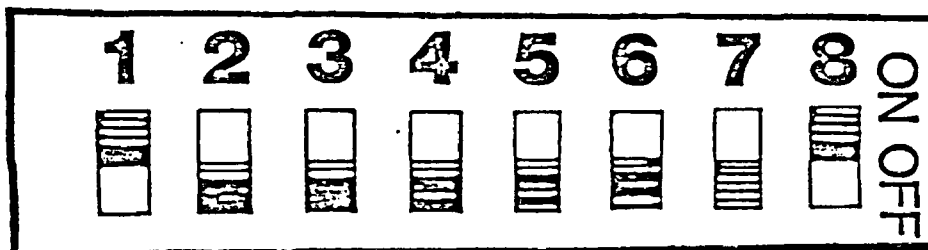
128K - 256K Dip Switch setting

The dip switch setting for the 128K memory board is 4B-1* and 4B-8 set to on, all others off.

Install the board into the second expansion slot on the CPU board. The first is the one nearest the disk drive assembly. The memory board is properly installed with components facing to the outside of the computer (away from the disk assembly).

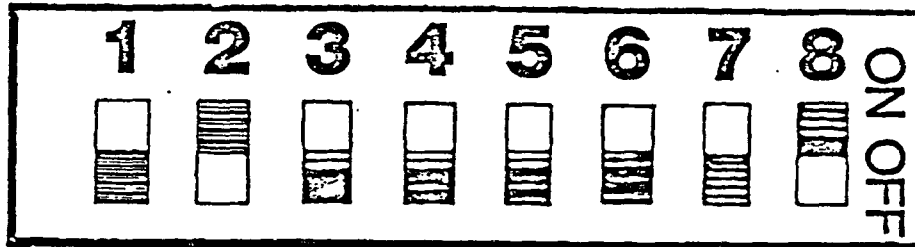
256 K - 384 K Dip Switch setting

The dip switch module at 4B selects the 128K block of memory in which the memory board will reside. Table 3.6A defines the memory blocks to switch settings.

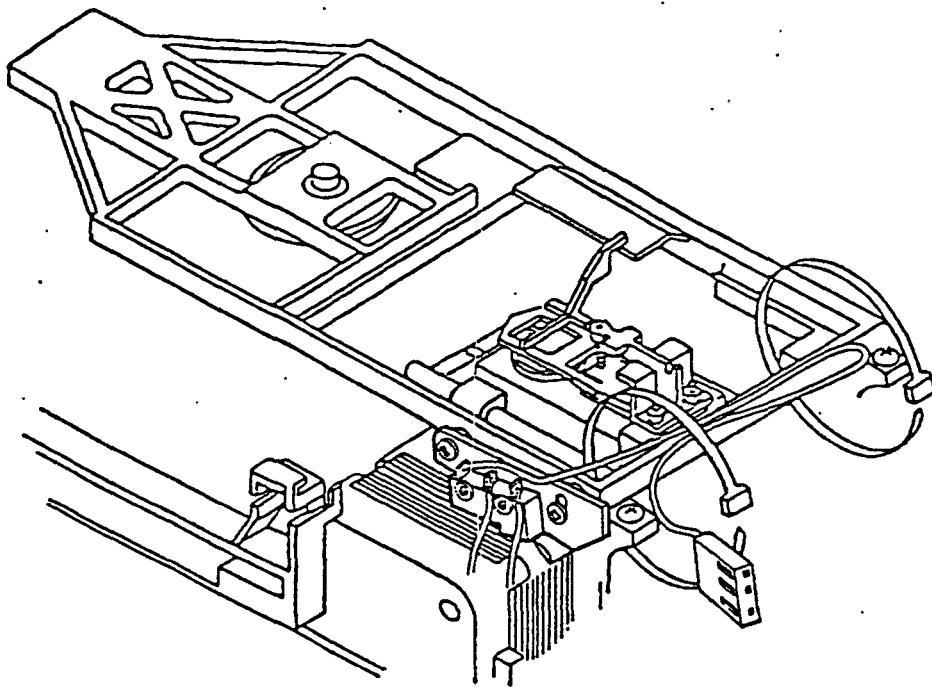
J8

2. Locate the 2 wires on the connector which connect to the 2 rear terminals of the switch. Remove these wires from the 3-pin Door Switch connector. Leave the front terminal wire attached to the 3-pin connector. This connector should be tie-wrapped to the rear of the Cone Lever assembly. This will retain the 3-pin connector to facilitate the installation of a X-100670 controller board at a later date.

3. Install the two wires to position 3 and 4 of the Write Protect connector for the A drive (J3). Since these wires are for the door switch, they may be connected to either pin.

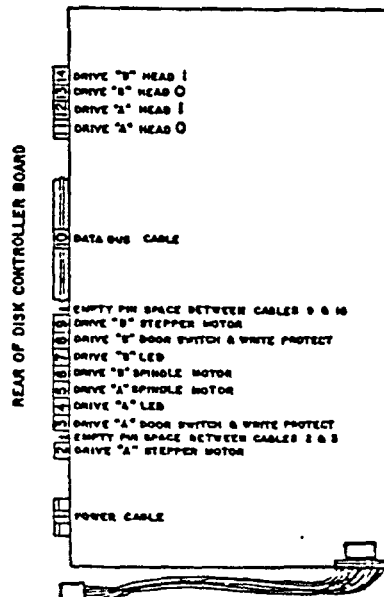
3. Install drive B, head 0 to J13. Head 0 is the lower head, and the connector will be marked with a 0.

4. Install drive B, head 1 to J14. Head 1 is the upper head, and the connector will be marked with a 1. This connector must be installed up-side-down for the pins to line up correctly.

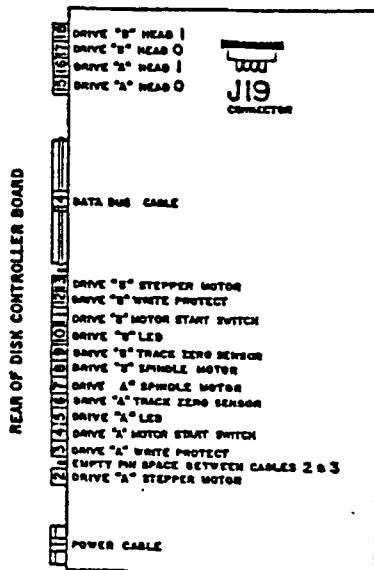
New style board (X-100670)

When installing the Double-Sided Disk Drive Units in a 9000 with the X-100670 controller board, a jumper must be installed from E3 to E4. This jumper will strap PB5 on the B Port of the 6522 at 1H to ground. All the connections remain the same as for Single-Sided Disk Drive Units with the exception of the R/W heads and the addition of a 3-pin connector for Door Switch. The 3-pin connector for the Door Switch is labeled the Motor Start Switch. The connectors are J4 for the A drive and J11 for the B drive. The R/W heads should be installed as follows:

1. Install drive A, head 0 to J15. Head 0 is the lower head, and the connector will be marked with a 0.
2. Install drive A, head 1 to J16. Head 1 is the upper head, and the connector will be marked with a 1.
3. Install drive B, head 0 to J17. Head 0 is the lower head, and the connector will be marked with a 0.
4. Install drive B, head 1 to J18. Head 1 is the upper head, and the connector will be marked with a 1.

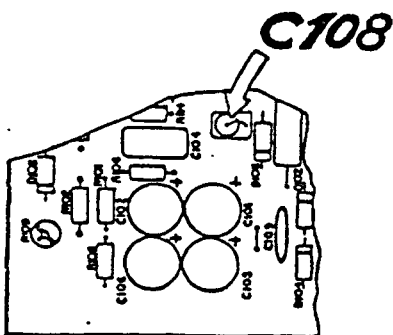
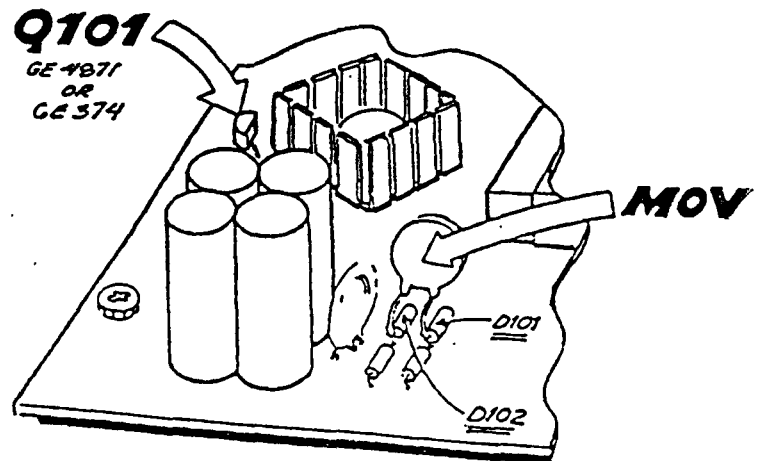
Any supply exhibiting this symptom is to be replaced by the field and returned to your Victor Field Engineering Depot for repair. The repair action requires a depot level recalibration procedure currently being accomplished only at Scotts Valley.

1. Add an MOV (P/N E-102091-01) across the anodes of D101 & D102.
2. Replace C108 with capacitor (P/N E-101855-01) .0033 10% 1KV
3. Place power supply in a computer and run computer under system test diagnostics for 24 hours.

Note: To expedite customer upgrade
The spares kit power supply should be updated and replaced in the spares kit for future on site replacement.

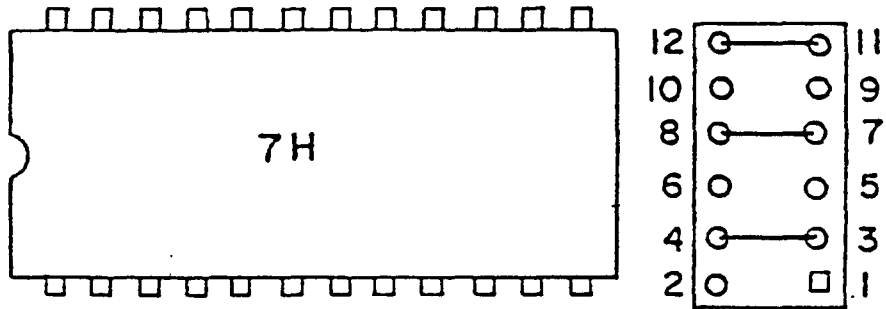
The BOOT PROMS are being changed to a 64K ROM. The new ROM is installed at location 7H, and replaces both of the old PROMS at locations 5H and 7H.

* Return BOOT PROMS to Scotts Valley, CA. *

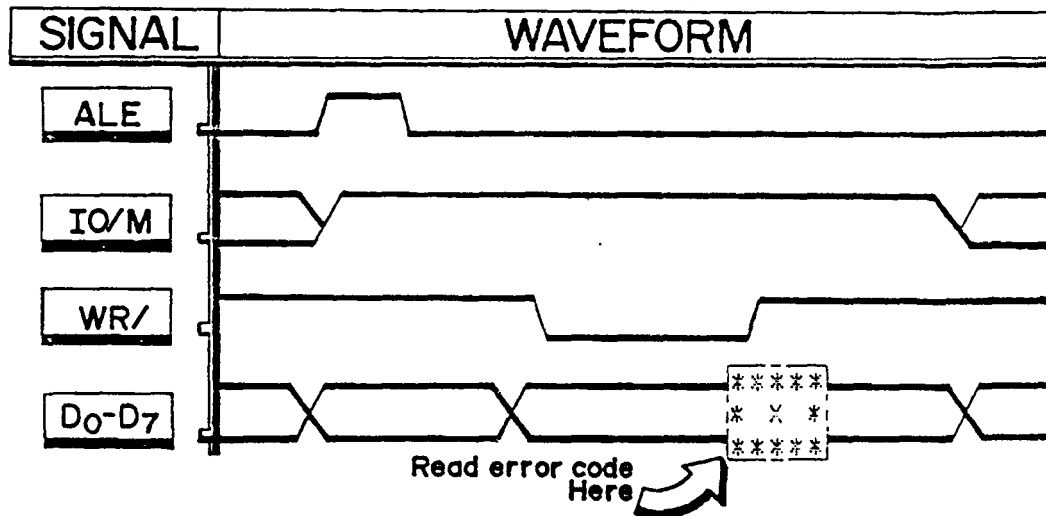
Figure 2

The method for more catastrophic errors is to report, via the output instruction, the type of error in the UPPER NIBBLE of the data byte, and if possible the failing device in the LOWER NIBBLE of the data byte. This is done by doing a write to IO port 0FFF Hex. The boot code then loops on this instruction allowing the operator to use an oscilloscope to examine D0 thru D7 and analyze the failure. One technique is to sync on the rising edge of the 8088's IO/M signal (pin 28) and then trace the upper and lower nibbles of the data lines D0 - D7 (available on the PIC pins 11 thru 4). The data is valid on the rising edge of WR/ (pin 29 of CPU), and when IO/M is high. See figure 2.

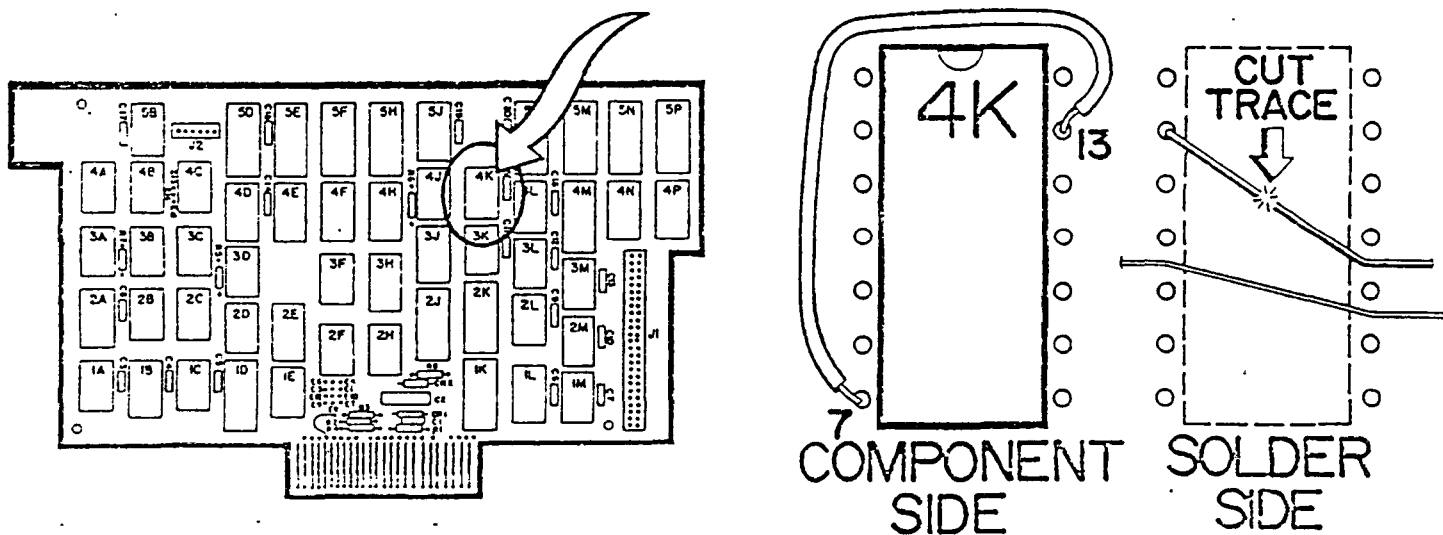
Hard disk units may fail to properly boot from the hard disk or may hang up under the operating system if the above configuration is incorrect.

To convert a 101160-01 to 101160-02 jumper 4K pin 13 to 4K pin 7 and cut trace on rear of board leading to 4K pin 13.

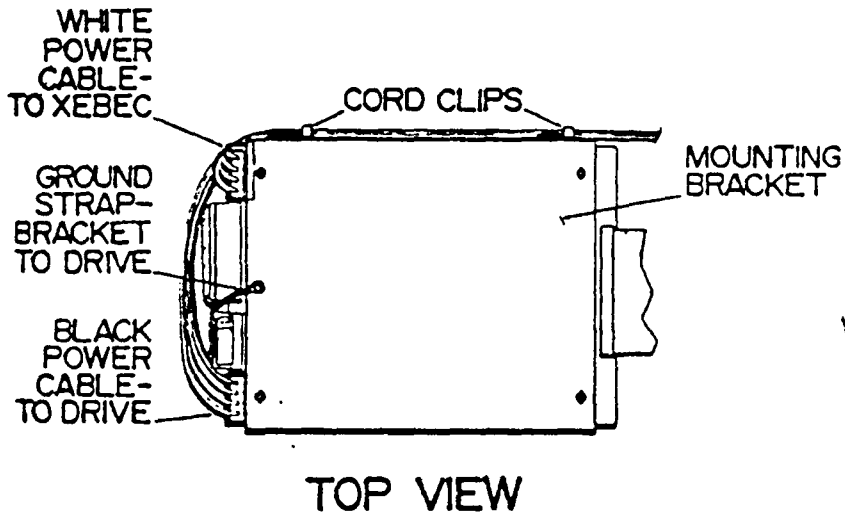
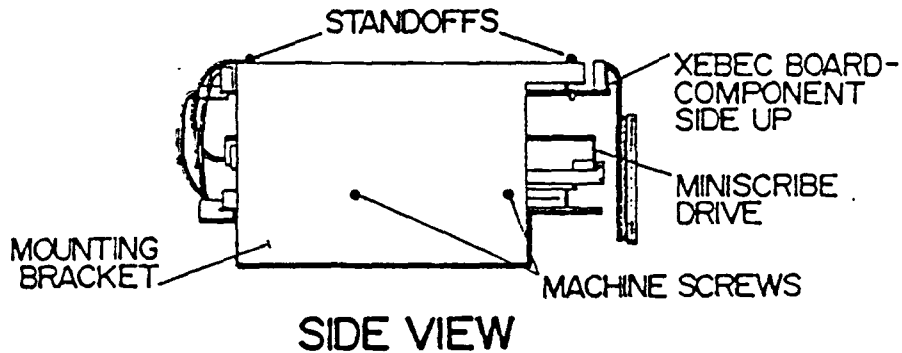
Miniscribe Assembly
Figure 2

It is important that the longer (7/8") standoffs, supplied with the Miniscribe, be used to mount the Xebec Board.

5. Connect the Ground Strap to the fast-on connector of the Miniscribe and using the Sem Screw attach the strap to the mounting bracket. (See Figure 2)
6. Connect and route the power cable (black to drive and white to Xebec Board) as shown in Figure 2. Connection and routing of the white power cable to the Xebec board requires special attention; Assure that the four wires from the connector (once connected to the Xebec Board) are routed tightly along it's side so that the wires protrude as little as possible above the connector. This prevents possible abrasion of the cable when the assembly is mounted in the Disk Chassis. Attach the two cable tie mounts along the lower edge of the bracket for proper routing of the power cables. The cables must be securely tie wrapped to these mounts.
7. Connect the Status/Control Cable and Radial Data Cable to the
