82545GM Gigabit Ethernet Controller Specification Update

June 6, 2006

The *82545GM* Gigabit Ethernet Controller may contain design defects or errors known as errata that may cause the product to deviate from published specifications. Current characterized errata are documented in this Specification Update.

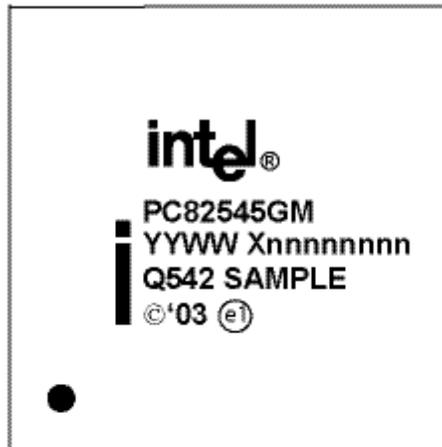
Lead-Free Device

Note: The black dot in the lower left-hand corner denotes pin 1.

Product	Stepping	QDF Number	Top Marking	Notes
82545GM	A0	Q522	RC82545GM	Engineering Samples
82545GM	A1	Q536	RC82545GM	Engineering Samples
82545GM	A1	-	RC82545GM	Production
82545GM	A1	-	PC82545GM	Lead-Free Production
